September 19, 2023

Project No.: 23-026

Re: Shanahan Park Gazebo – Structural Inspection & Assessment

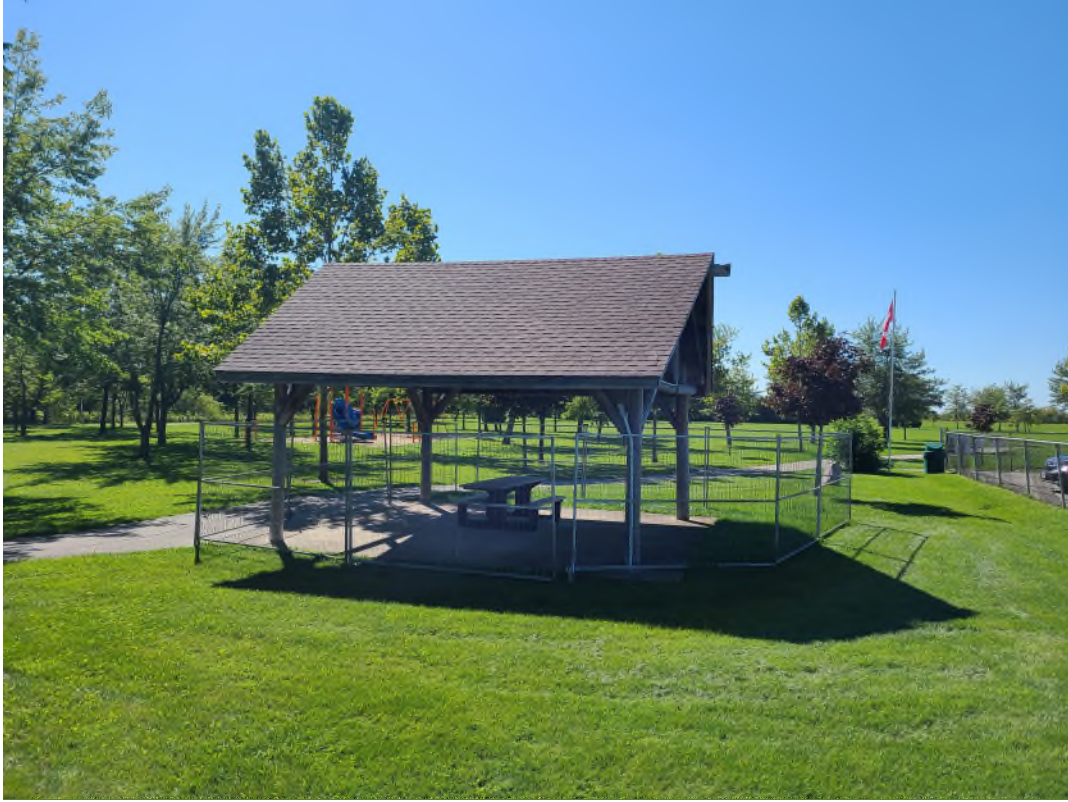
- This existing gazebo structure generally consists of a round-timber frame, supporting a cut-timber and plywood roof structure, covered with asphalt shingles (see Photo #1);

- The existing roof shingles generally appear to be in good condition (see Photo #1).

Photo #1: Shanahan Park Gazebo - General View (looking west)

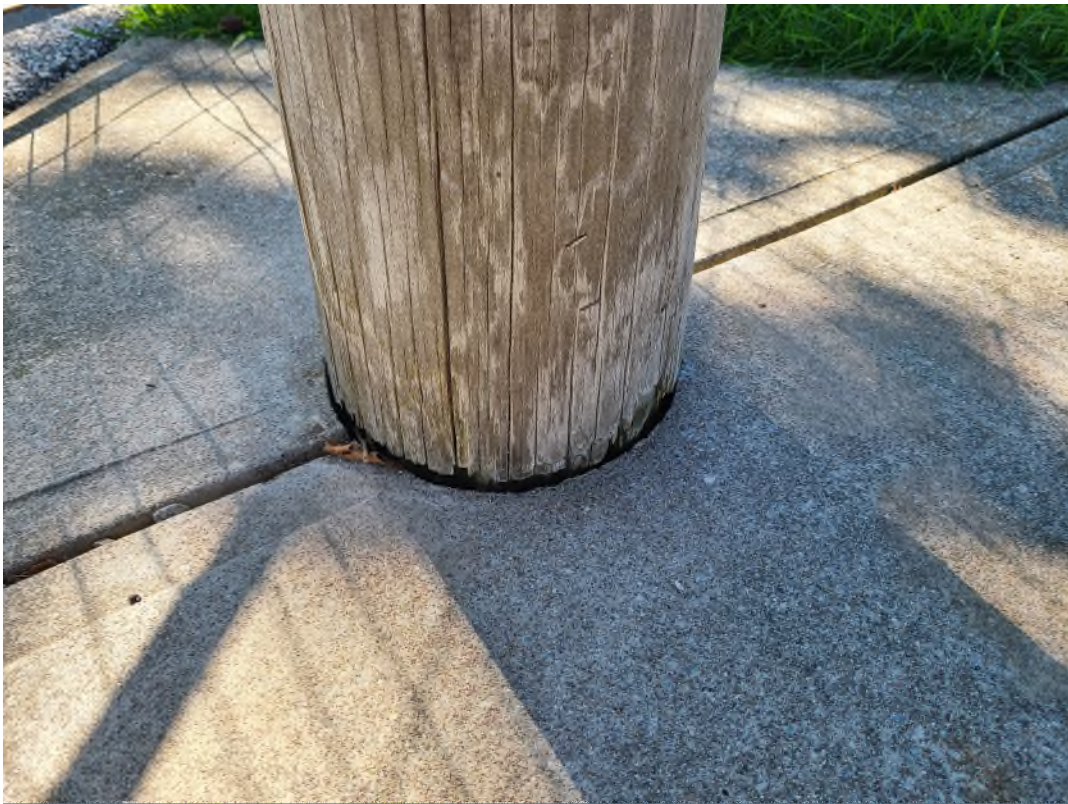
- The four timber posts that serve as the primary supports for the existing structure were embedded into the ground as part of the original construction, with a concrete surface slab poured around each post (see Photo #2 & Photo #3);

Based on the findings of our inspection, it is our opinion that the primary structural concern regarding the existing gazebo is associated with the rot that is occurring in the primary post supports at (and immediately below) ground level. Generally speaking, it is not recommended to embed structural timber posts directly into concrete, as a gap will typically form at the interface between the wood and the concrete and allow moisture to get trapped against the post. This tends to promote rot and leads to the deterioration of the timber over time.

Photo #2: Timber Rot at base of Southwest Post Support

To address this issue, the existing gazebo structure could potentially be repaired by temporarily supporting each post and then casting new concrete footings below, from a point approximately 600mm above existing grade down to frost depth. The deteriorated post bottoms would be cut off and then re-attached to the new footings using galvanized or stainless-steel sleeves bolted into the concrete.

Given the above, we would not recommend that the Municipality of Lakeshore proceed with the considerable expense of designing, constructing and maintaining a new foundation system for the gazebo in an effort to preserve an existing structure that realistically has less than 10 years of remaining service life. It is our opinion that the Municipality would be better served by simply demolishing the existing structure and constructing a new gazebo that would be in full compliance with current building code standards.

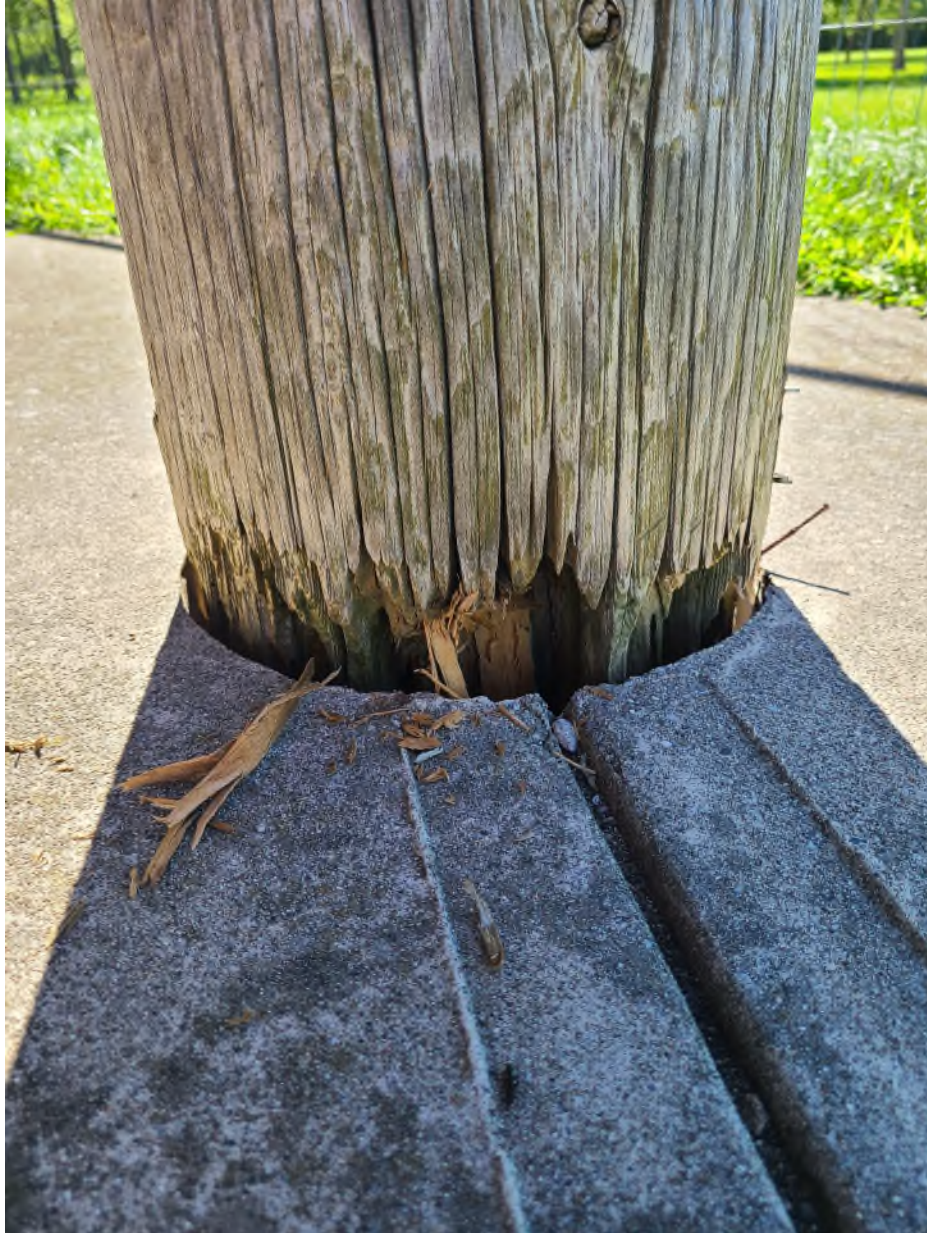
- The embedded timber posts are exhibiting significant rot and loss of section at ground level – with the two posts on the north side of the gazebo having the most severe deterioration (up to 3” in depth). Gentle probing of the wood near the base of the northwest post (using a ballpoint pen) resulted in significant splintering of the existing timber surface (see Photo #3);

Photo #3: Substantial Timber Rot at base of Northwest Post Support

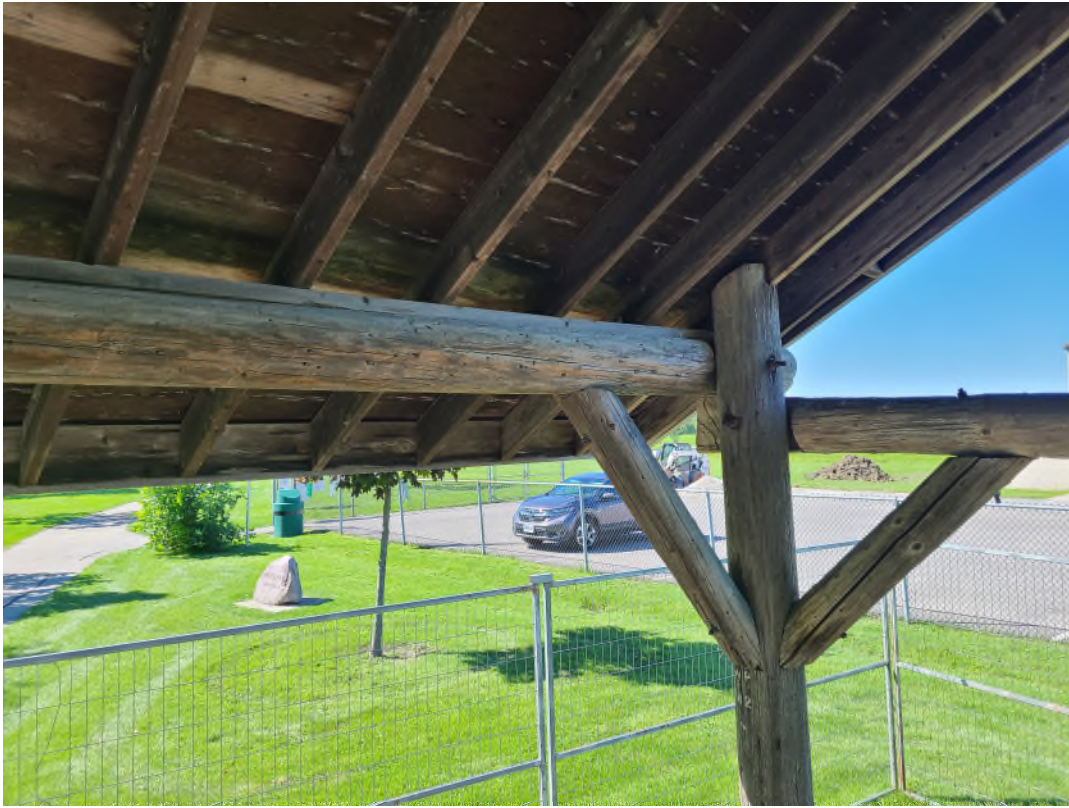
- The horizontal round-timber framing members and strut supports generally appear to be in fair condition, with significant cracking and checking noted in several members (see Photo #4, Photo #5, Photo #6 & Photo #7);

- The existing steel bolts and plates that form the primary connections between the round-timber framing members of the gazebo are exhibiting moderate corrosion over their exposed surfaces, but generally appear to be intact (see Photo #4 & Photo #5).

- The existing roof structure generally appears to be in good condition, although significant weathering of the rafters and plywood roof sheathing was noted (see Photo #4, Photo #5 & Photo #6); and,

Photo #4: Typical Top-of-Post Connection

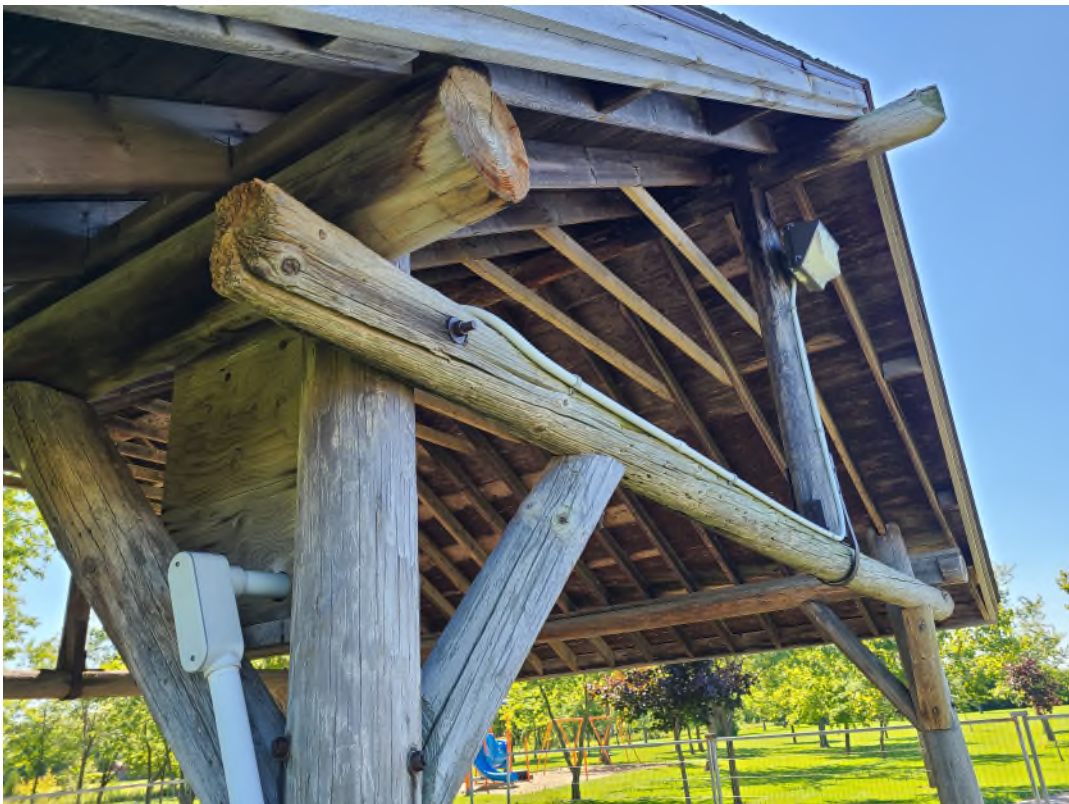
Photo #5: General View – Gazebo Framing along South Face

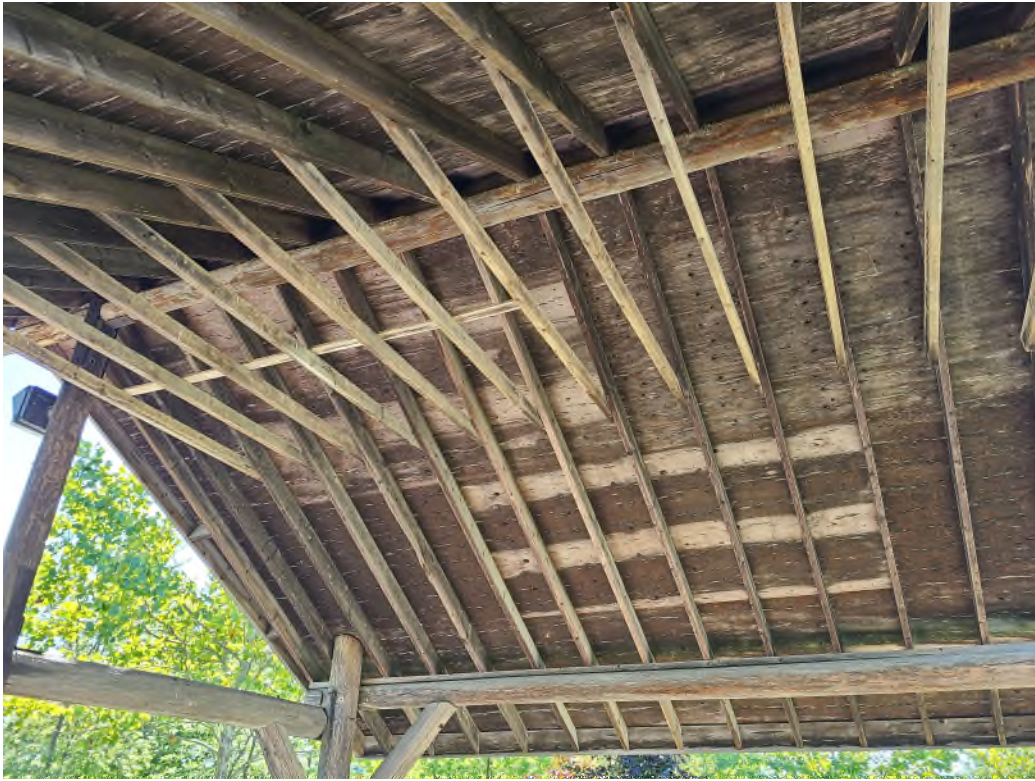
Photo #6: General View – Typical Roof Framing

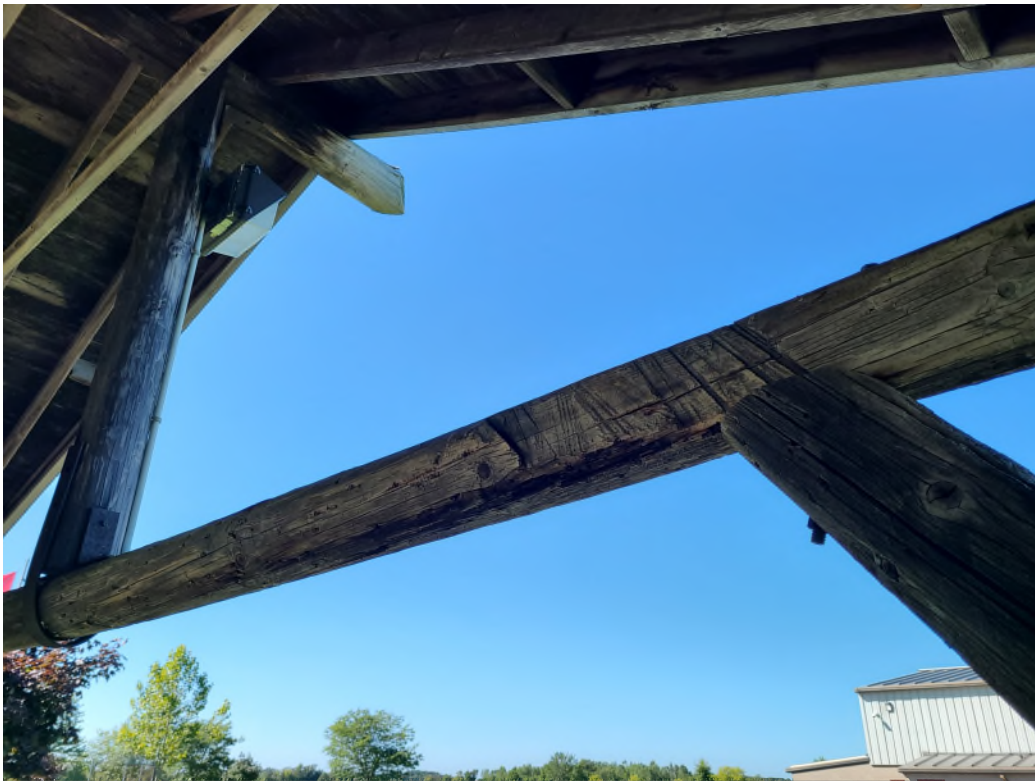
Photo #7: Significant notching, abrasion & checking on horizontal framing member
