Belle River Dyke Inspections
Summary of Observations

BELLE RIVER FLOOD CONTROL PROJECT
BELLE RIVER DYKING INSPECTIONS

**BELLE RIVER FLOOD CONTROL PROJECT
INSPECTION REPORT**

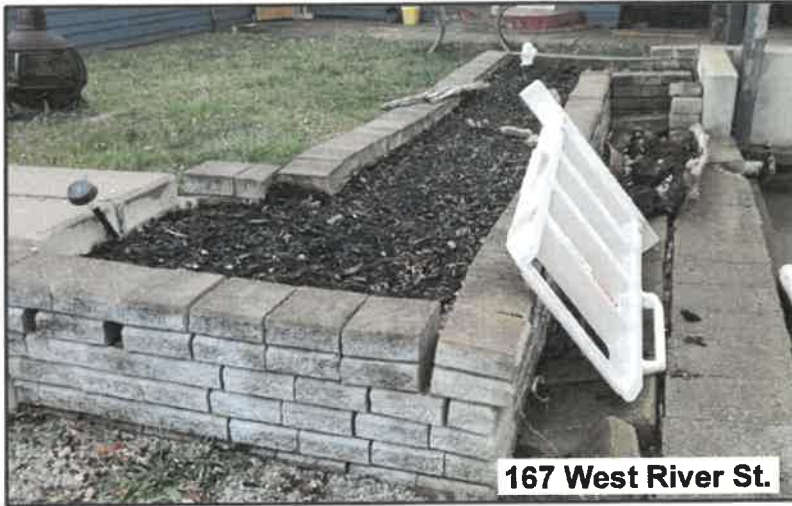
167 West River St.

Minor settlement of fill in Double-Retained Berm section; some distorted and visibly unstable segments of retaining wall (i.e., leaning and/or loose bricks) and gaps at berm ends and transitions to adjacent structures.

Top up retained berms with soil; reconstruct severely distorted segments of retaining walls as required to restore stability.

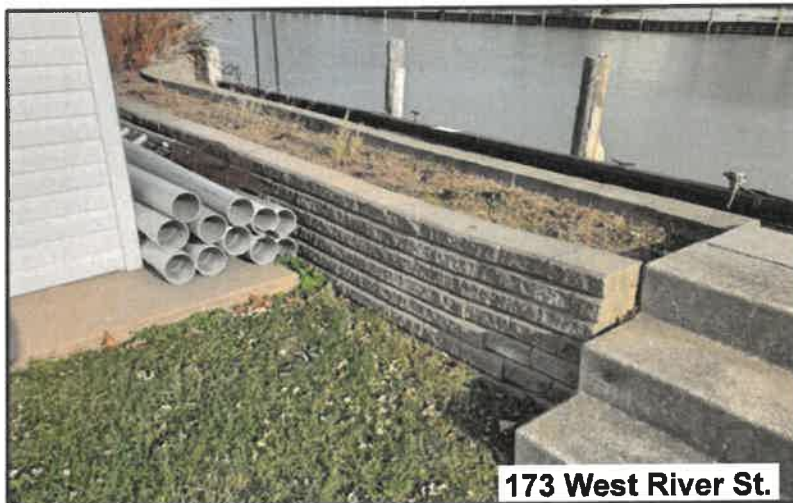
173 West River St.

173	West River	Double-Retained Berm	Deficient	Settlement of retained fill (thickness of a brick). Minor outward lean to short segments of retaining wall.
183	West River	Earth Berm	Fair	Settlement of earth berm near transition to north abutting, double-retained berm.
625	Notre Dame	Concrete Wall	Deficient	No backflow valve at CB. Minor gap between concrete wall and berm near lookout. Shorewall appears reasonably stable. Some anchor rods are exposed and rusting. Minor settlement of concrete wall south of the old spillway.
188	First Street	Single-Retained Berm	Fair	Minor vertical deflection / heaving of retaining blocks, apparently due to roots of adjacent tree.
178	First Street	Earth Berm	Deficient	Berm elevation at long gravel paths (between edging stones) is low.
168	First Street	Double-Retained Berm	Fair	Minor settlement of retained fill.
154	First Street	Earth Berm	Deficient	Settlement behind existing SSP shorewall may indicate long term instability. Top elevation of berm is low (176.22-176.36m)

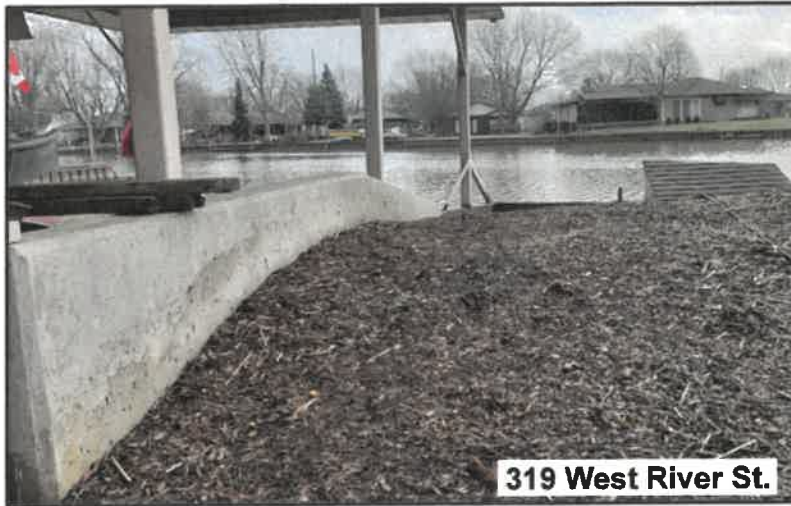
319 West River St.

327	West River	Earth Berm	Fair	Minor settlement of berm at north property limit.
323	West River	Earth Berm	Fair	Minor settlement of berm at south property limit.
319	West River	Earth Berm	Deficient	Settlement of berms that abut boathouse.
309	West River	Earth Berm	Deficient	Minor localized settlement of berm.
301	West River	Earth Berm	Deficient	Minor settlement of berm at north property limit.
295	West River	Earth Berm	Deficient	Minor settlement of berm at south property limit.

Low or discontinuous earth berm - probably due to settlement.

Top dress / extend earth berms as
required to restore the design top of dyke
elevation of 176.48 m (based on GPS
datum).

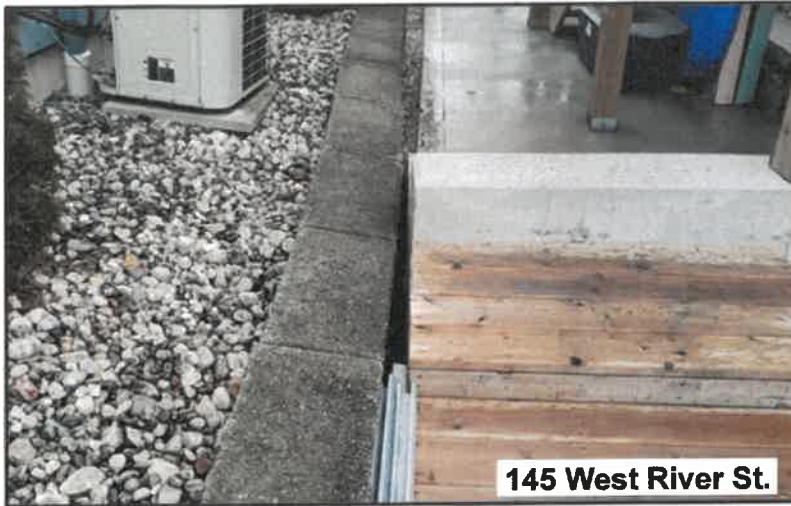
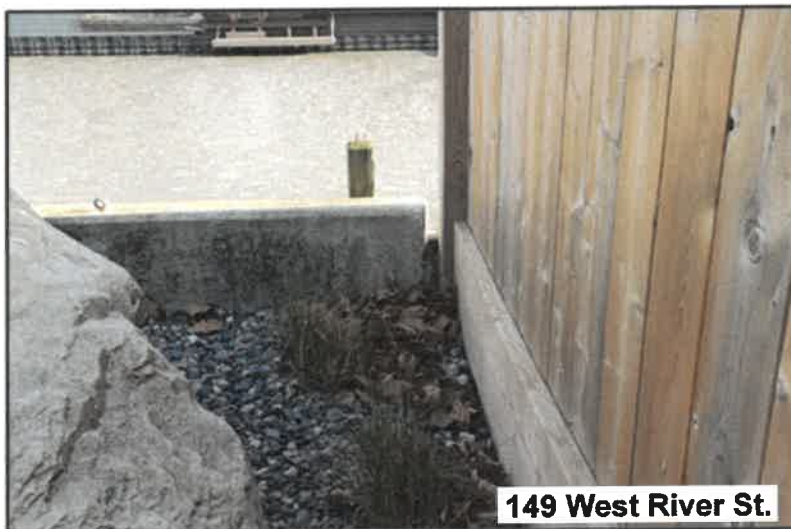
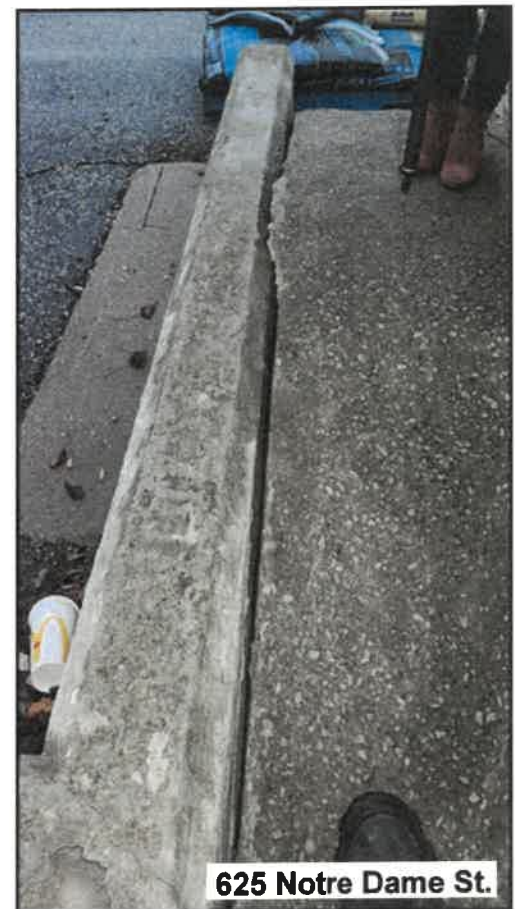
Gap in dyke at termination of concrete walls and/or at transitions to other structures.

Fill gap with appropriate filler or backer material and reseal with caulking.

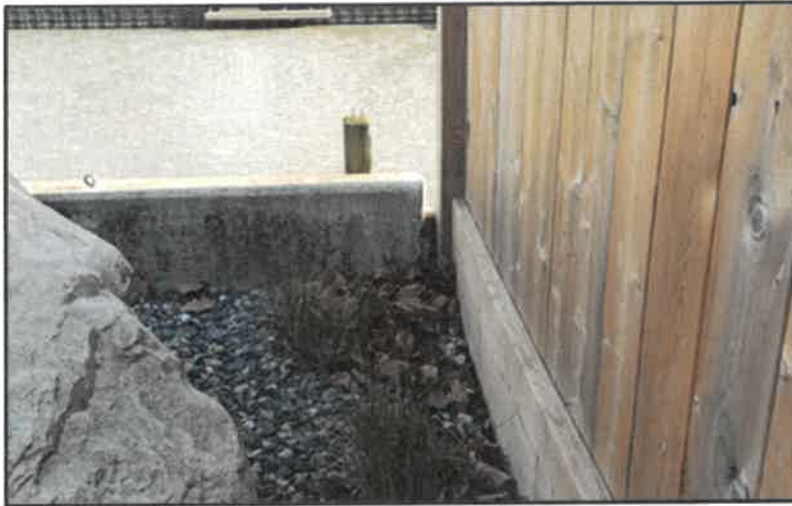
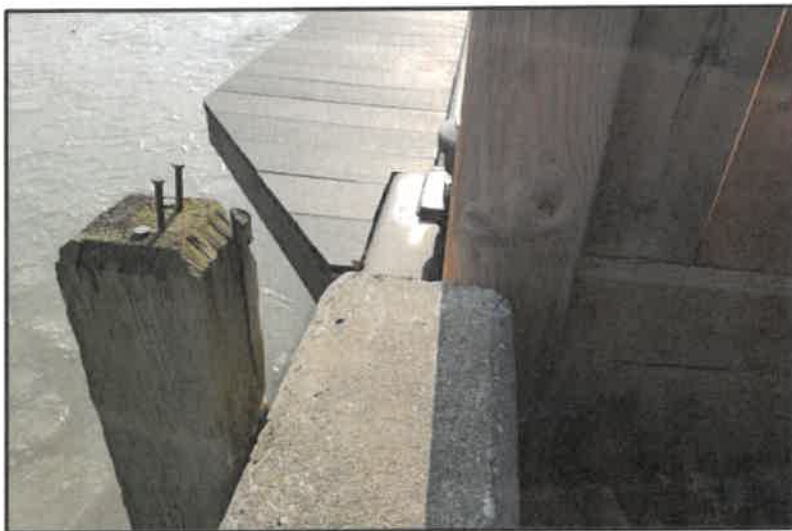
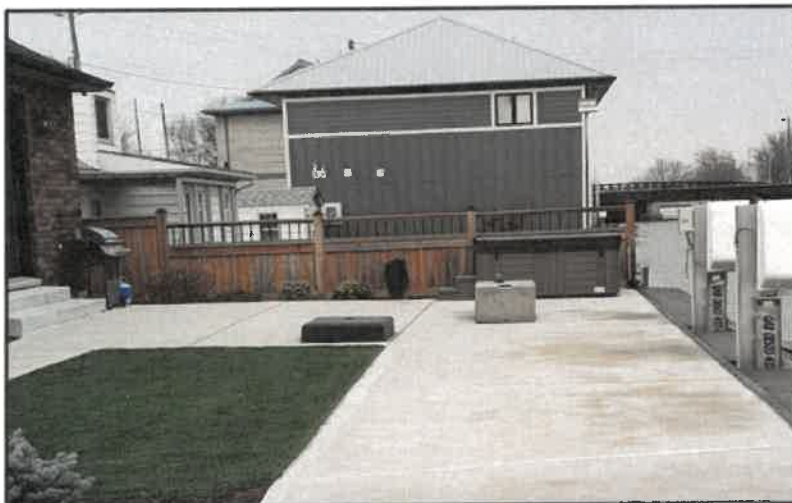
Dyking is not continuous through adjacent properties. Concrete wall is abruptly terminated at property line, which will allow flood water to outflanking of the dyke and spill inland.

Further assessment needs to be undertaken to determine most appropriate repair. (Possible solution would be removing existing fence, construct a curb matching top of wall and tying back into property)

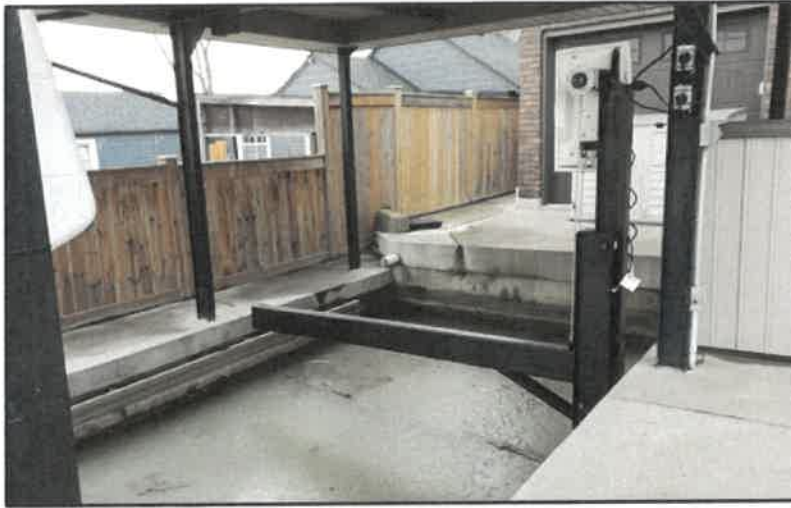
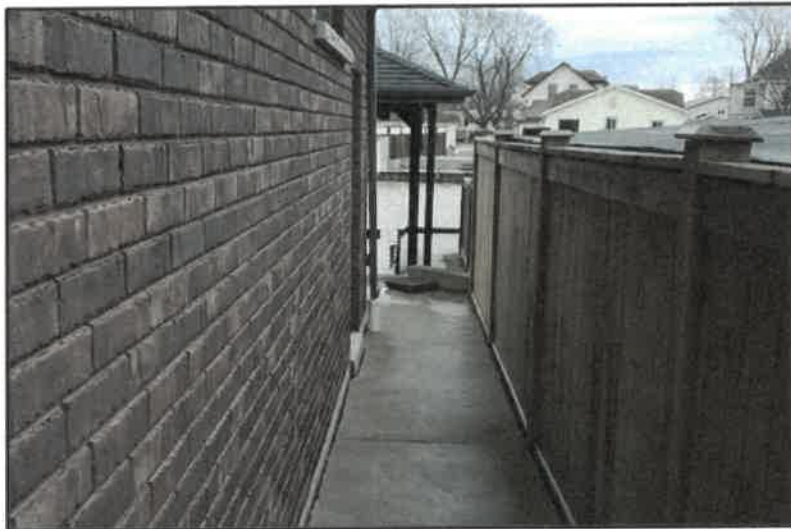
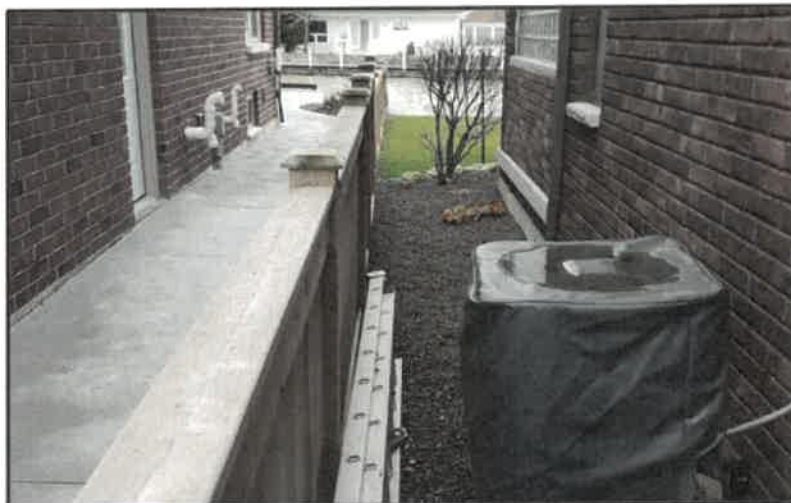
The dyking is not continuous on north and south sides of the new dwelling. Improper transitions to adjacent properties will allow floodwaters to outflank the dyke and spill inland.

A more thorough evaluation of remedial options needs to be undertaken in consultation with affected property owners before an appropriate scope of repairs can be identified.

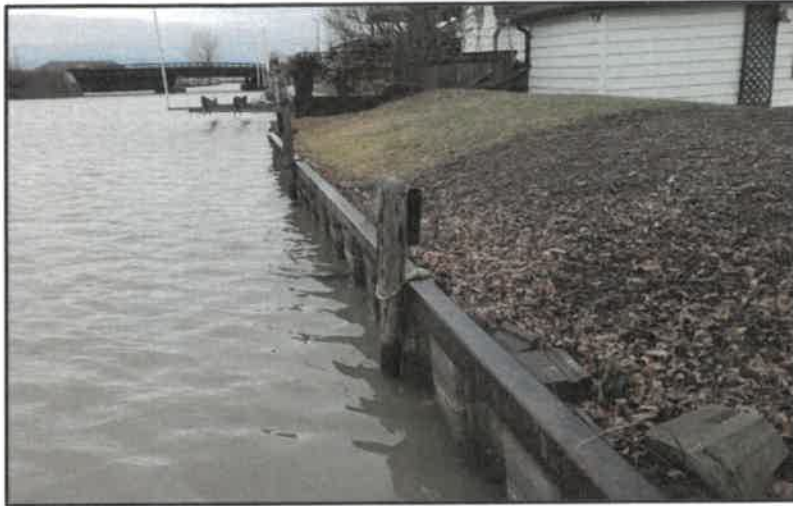
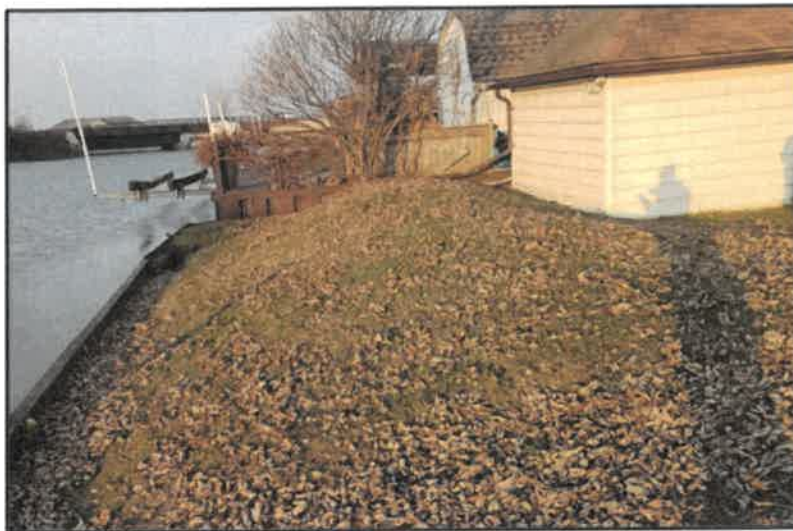
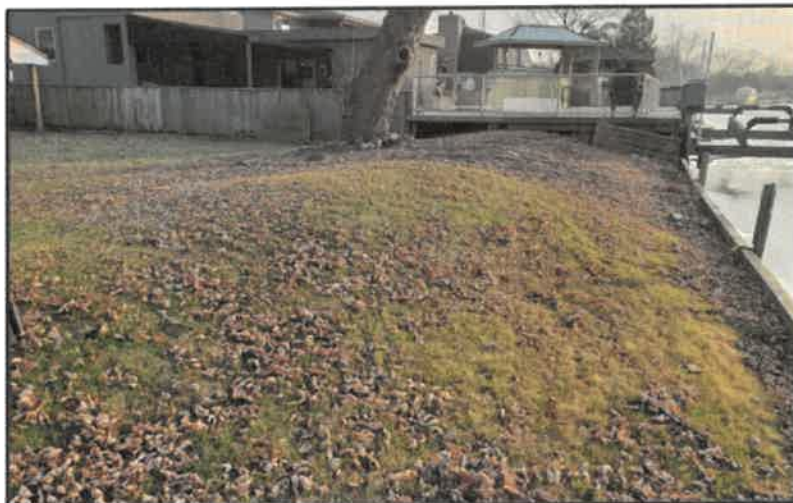
The long-term stability of the SSP shorewall is unknown. Top elevation of berm is too low.

A more detailed assessment of this site is required to confirm the long-term stability of the shorewall before a proper scope of remedial measures can be identified.

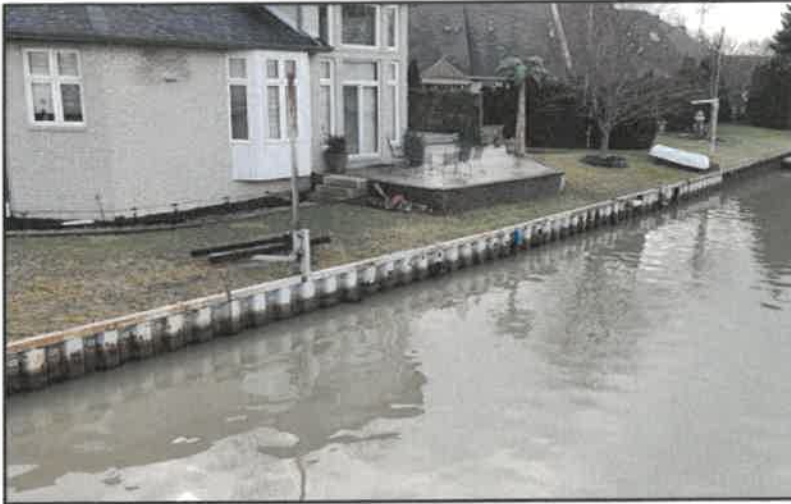
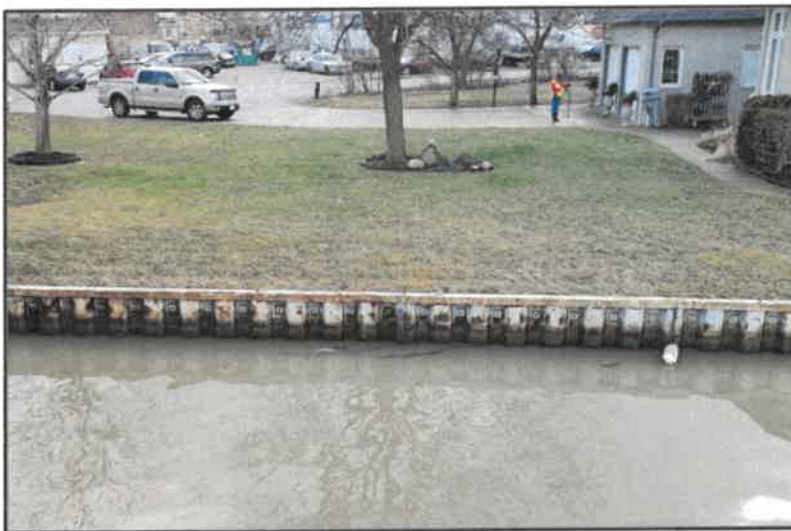
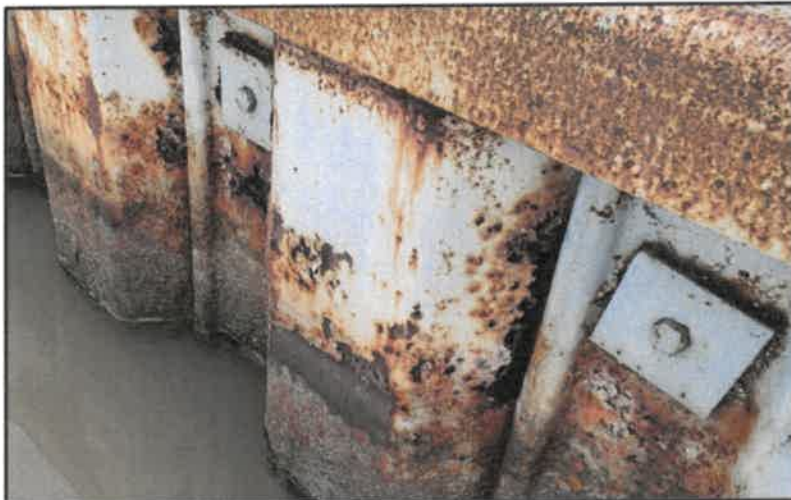
Dyking is non-existent on the north side of the dwelling. The absence of a dyke will allow floodwaters to spill inland. Numerous perforations noted in SSP wall.

A more thorough evaluation of remedial options needs to be undertaken in consultation with affected property owners before an appropriate scope of repairs can be identified.

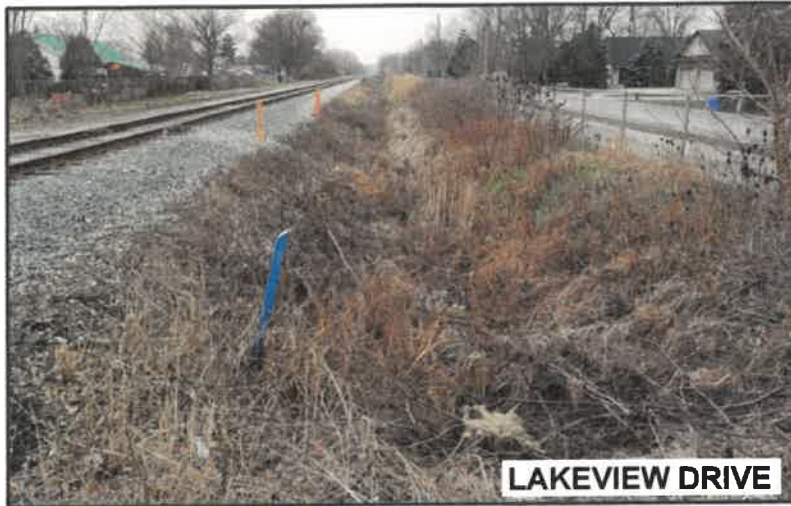
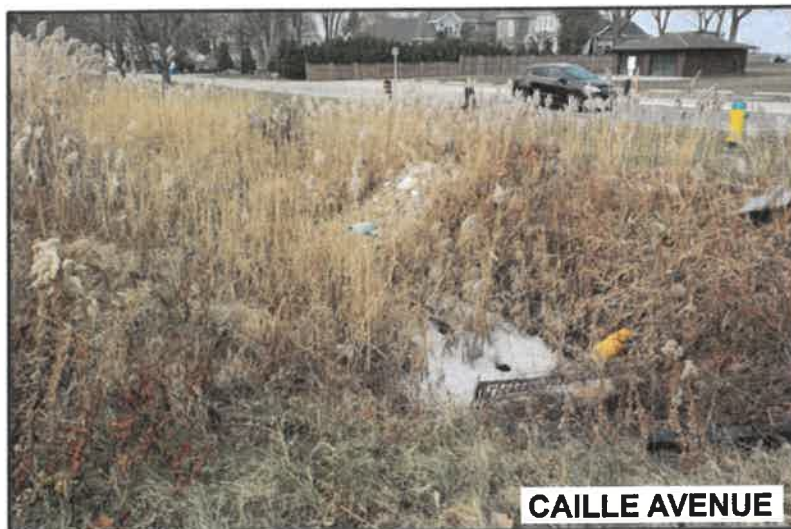
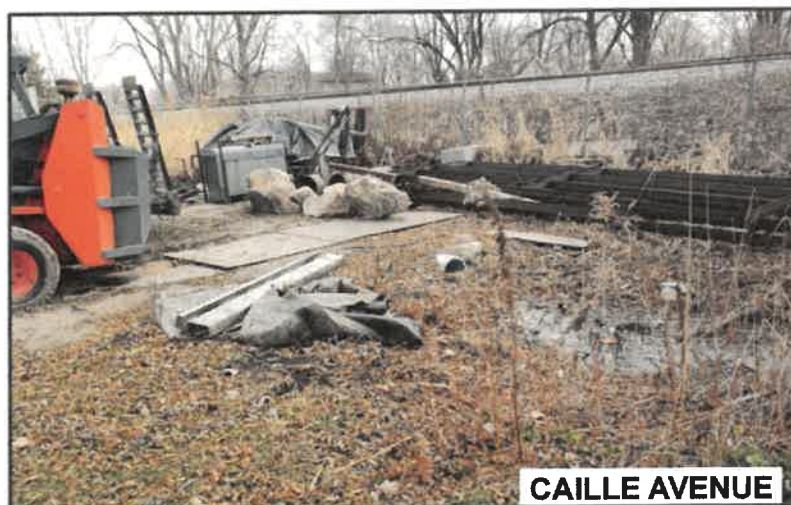
Existing ditches are significantly fouled with woody vegetation and phragmites. Privately constructed drain enclosures and infills along Caille Avenue further compromise conveyance capacity.

Clear existing ditches of vegetation along both drains and compile inventory of encroachments along Caille Avenue.
