**Scoped Heritage Impact Assessment
and
Commemoration Strategy
7119 Tecumseh Road
Municipality of Lakeshore
Lot 7, Concession 1
Geographic Township of Tilbury West
Essex County**

By
Archaeological Research Associates Ltd.
219-900 Guelph Street
Kitchener, ON N2H 5Z6
Tel: (519) 804-2291

02/09/2022

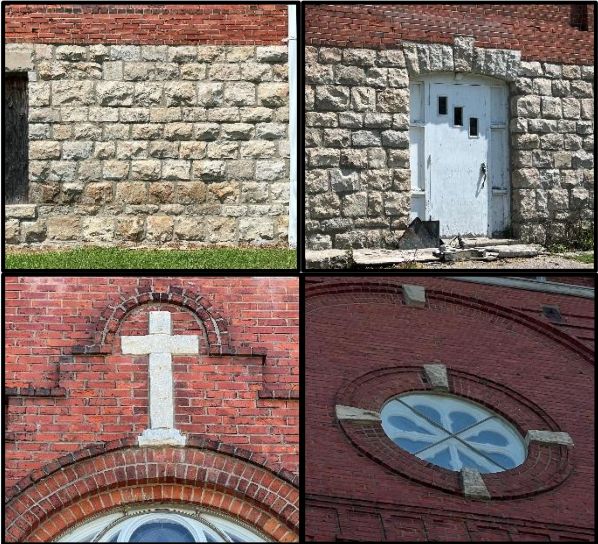
Limestone	Limestone Foundation and Detailing	Fair	<p>The foundation's limestone masonry was observed to be in good condition overall; however, previous repairs and repointing appear to have used cementitious mortar on all elevations. The use of this mortar type will make salvaging of individual masonry units more difficult.</p> <p>The foundation masonry units and voussoirs and keystone detailing around openings have the potential to be salvaged and used as part of a commemoration plan.</p> <p>Masonry units not used as part of a commemoration strategy should be considered for salvaging and reuse elsewhere.</p> <p>The limestone cross on the church's façade was observed to be in good condition and have the potential to be salvaged and used as part of a commemoration plan. The date stone also appears in good condition and has the potential to be salvaged and used as part of a commemoration plan.</p>

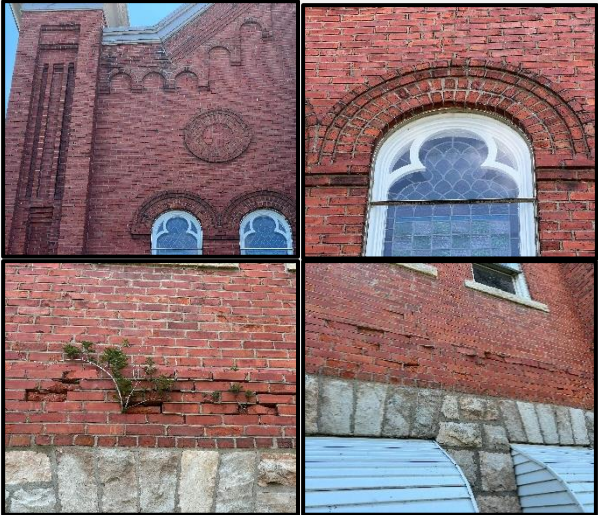
<p>Red Brick</p>	<p>Brick Walls, Decorative Brickwork, Brick Chimney</p>	<p>Poor to Fair</p>	<p>Condition of bricks ranges across the building from poor to fair. Extensive cracking, spalling and loss of masonry units were observed across all elevations.</p> <p>Previous repairs and repointing using inappropriate, cementitious mortar has furthered brick deterioration. The use of this mortar type will make salvaging of individual masonry units more difficult.</p> <p>A selection of brick masonry units, or a portion of the decorative brick masonry such as the projecting brick voussoirs kept intact have the potential to be salvaged and used as part of a commemoration plan.</p> <p>Given the advanced deterioration of the brick masonry units and the use of a hard mortar type, the majority of bricks are unlikely to be suitable for salvage for recycling/reuse elsewhere.</p>

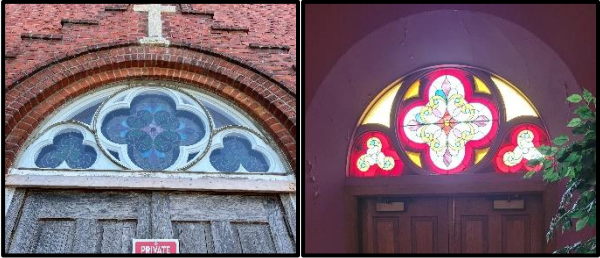
<p>Wood and Leaded Glass</p>	<p>Round Arched Transom Window</p>	<p>Poor to Good</p>	<p>Both the wooden tracery and leaded glass panels that compose the round arched transom window were observed to be in good condition. An exterior panel has protected the window from exposure.</p> <p>As a primary window fixture located on the main entrance along the façade of the church, the round arched transom window is considered a distinctive component of the building's design and is included as a heritage attribute in the property's designation By-law. As such, the window should be considered a high priority to be included in a commemoration plan.</p> <p>If the window or window material is not selected for use in a commemoration plan, it is recommended for salvage or recycling/reuse elsewhere.</p>

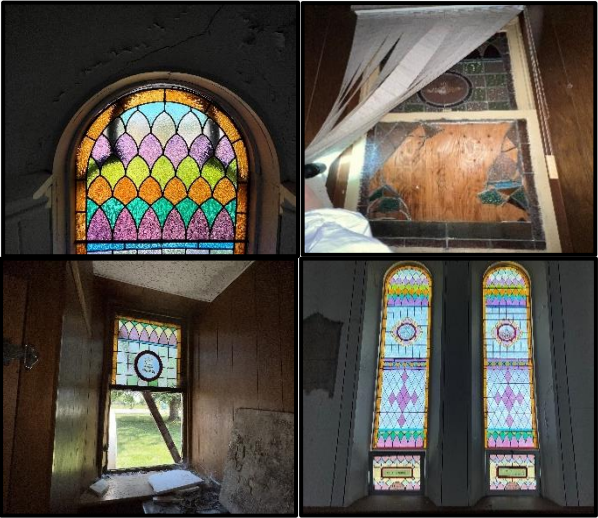
<p>The photo section contains four images: top-left shows a well-preserved arched stained glass window with a colorful geometric pattern; top-right shows a window with missing glass and exposed wooden framing; bottom-left shows a window with a large section of glass missing, revealing the exterior; bottom-right shows two tall, narrow stained glass windows with similar colorful patterns.</p>	<p>Wood and Leaded Glass</p>	<p>Stained Glass Windows</p>	<p>Missing/ Poor to Fair</p>	<p>The condition of both the wooden frames and leaded glass panels that compose the stained glass windows throughout the church varied from poor to good with some windows missing or entirely broken. Deterioration noted included worn and broken lead connectors causing bowing and warping of the window as well as missing glass pieces.</p> <p>As a defining element of the church's design, viable windows, or windows with the least deterioration should be considered high priority for salvage and considered for incorporation into a commemoration plan.</p> <p>If only a selection of the windows are to be retained for future use in a commemoration plan, the remaining windows should be considered for salvage or recycling/reuse elsewhere.</p>

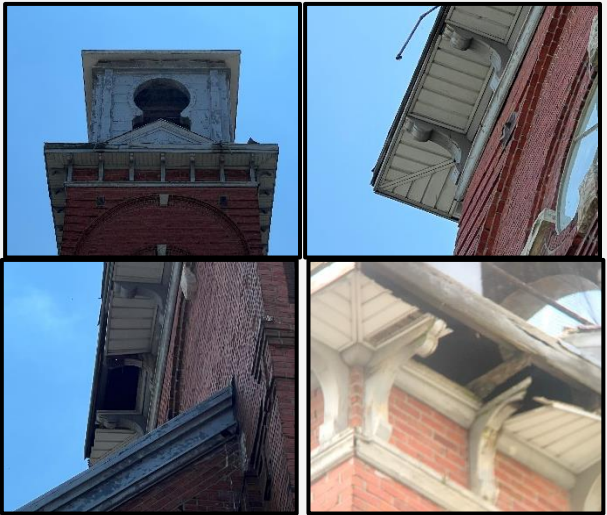
Wood	Wooden Stringcourse, Brackets and Eaves around Belltower	Poor to Fair	<p>Field survey was limited to views from the ground only, potentially limiting views of the material and any associated deterioration.</p> <p>The wooden components of the stringcourse, brackets and eaves ranged in condition, with some eave boards completely deteriorated/missing and brackets broken. Damage was primarily evident on the east side.</p> <p>The wooden components on all sides showed moderate cosmetic damage, with flaking and missing paint finishes.</p> <p>Where viable, the wooden brackets should be considered for salvaging and reuse as part of a commemoration plan.</p> <p>It is unlikely that the wooden boards composing the soffit and string course will be viable for recycling/reuse elsewhere and are not considered viable for salvage.</p>

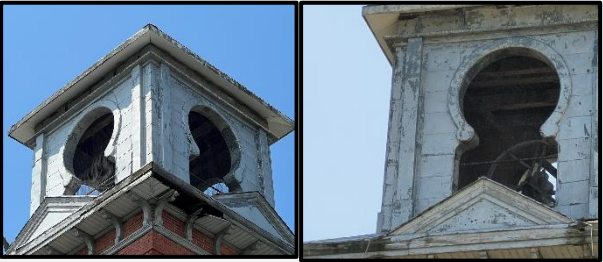
<p>Pressed Tin</p>	<p>Belfry</p>	<p>Poor to Fair</p>	<p>Field Survey was conducted from the ground level, potentially limiting views to the condition of this heritage attribute.</p> <p>The pressed tin/sheet metal belfry appeared to be in fair condition overall, with select areas in poor condition showing signs of corrosion and pitting. This deterioration is likely associated with an eroded painted or tin finish which has fostered an environment for corrosion.</p> <p>The primary deterioration viewed on the belfry is a flaking paint finish. While this does leave the material more exposed to potential further deterioration, this is currently a cosmetic deterioration.</p> <p>As a defining characteristic on the façade of the building and a listed heritage attribute in the designation By-law, the belfry should be considered for incorporation or salvage as part of a commemoration plan.</p>

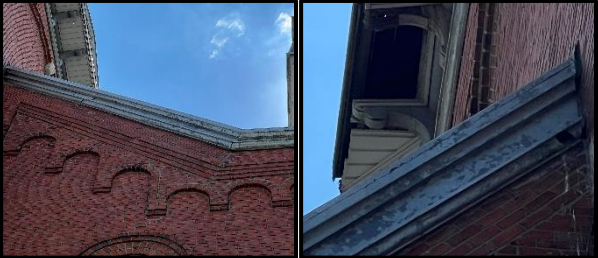
<p>Pressed Tin</p>	<p>Parapet</p>	<p>Fair</p>	<p>Field Survey was conducted from the ground level, potentially limiting views to the condition of this heritage attribute.</p> <p>The pressed tin/sheet metal parapet walls appeared to be in fair condition overall with moderate deterioration in the form of a flaking paint finish. While this does leave the material more exposed to potential further deterioration, this is currently a cosmetic deterioration.</p> <p>While the parapet wall is located on the façade of the building and is included as a listed heritage attribute in the designation By-law, the pressed tin/sheet metal components of the parapet wall will be less interpretable when removed from its context, making it less suitable for incorporation into a commemoration plan.</p> <p>Salvage of the metal material should be considered however to allow for the potential recycling/reuse elsewhere.</p>

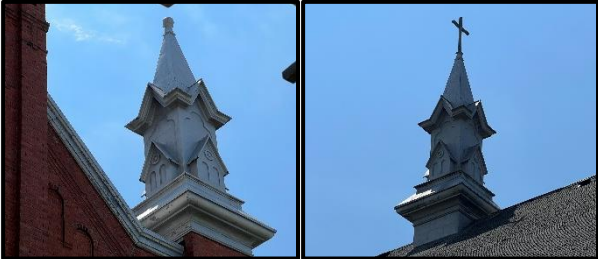
<p>Pressed Tin</p>	<p>Pinnacles/Spirelet</p>	<p>Good</p>	<p>Field Survey was conducted from the ground level, potentially limiting views to the condition of this heritage attribute.</p> <p>The pressed tin/sheet metal pinnacles and spirelet appeared to be in good condition overall, with minimal deterioration observed, limited to areas with a slight flaking paint finish. deterioration.</p> <p>As a defining characteristic on the façade of the building and a listed heritage attribute in the designation By-law, the entire pinnacles/spirelet should be considered for incorporation or salvage as part of a commemoration plan.</p>

- The heritage committee should determine if a commemorative plaque should be employed as a means of symbolic conservation immediately. If so, salvage materials to be used should be clearly communicated prior to and demolition efforts. ARA would recommend that at minimum a selection of brick and stone masonry units and exterior pressed tin such as the pinnacles and spirelet be salvaged and integrated into the design of the commemorative plaque.

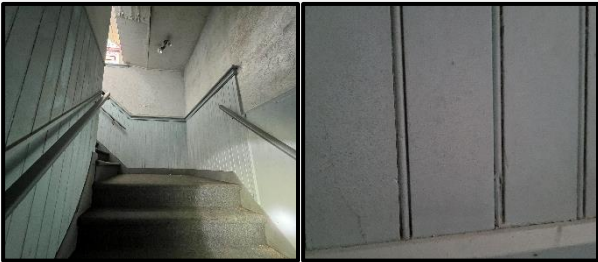
Wood	Basement Wainscoting	Fair	<p>The beadboard wainscoting located in the basement stairwells were in overall fair condition, with boards and bead profile intact and no rotting or missing elements noted.</p> <p>The surface of the wooden boards showed signs of biological growth (mold), likely a result of the standing water throughout the basement level. At the time of the site visit, this mold had not penetrated the wooden members and has the potential to be cleaned from the wood.</p> <p>While these materials are listed as heritage attributes in the property's designation By-law, they are not considered to be distinctive to the design of this church specifically and are not a priority to be included as part of a commemoration plan.</p> <p>Salvage of the wooden material should be considered to for recycling/reuse elsewhere.</p>

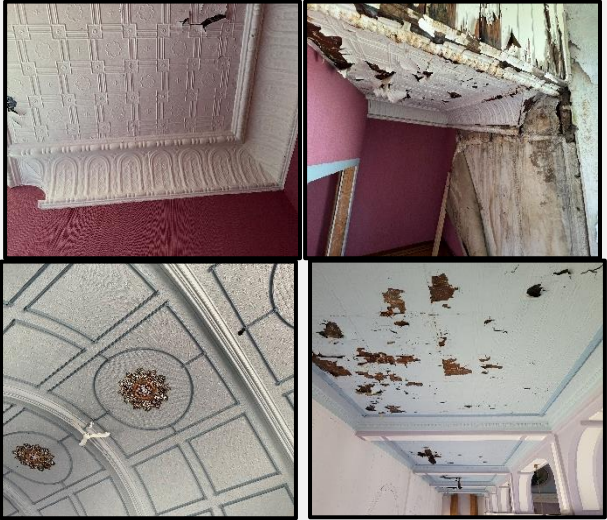
<p>Pressed Tin/Sheet Metal Panels</p>	<p>Ceiling</p>	<p>Poor to Good</p>	<p>The pressed tin/sheet metal ceiling tiles throughout the church were in varying condition. Portions of the ceiling panels showed significant deterioration and corrosion, as a result of water infiltration issues. However, much of the vaulted ceiling showed mild to no deterioration outside of a flaking paint finish.</p> <p>As the ceiling is composed of pressed tin/sheet metal panels there is the potential to remove and salvage viable panels. Ceiling tiles with elevated levels of deterioration are not suitable for salvage.</p> <p>While the pressed tin/sheet metal ceiling is included as a heritage attribute in the property's designation By-law,</p>

PHOTO	MATERIAL	HERITAGE ATTRIBUTE	CONDITION	COMMENTS
				<p>they are not considered to be distinctive element in isolation. If appropriate, a portion of the ceiling material could be removed and conserved as part of a commemoration/interpretation plan for the property.</p> <p>If the ceiling panels are not selected to be a part of a future commemoration plan the materials should be salvaged for reuse/recycling elsewhere.</p>

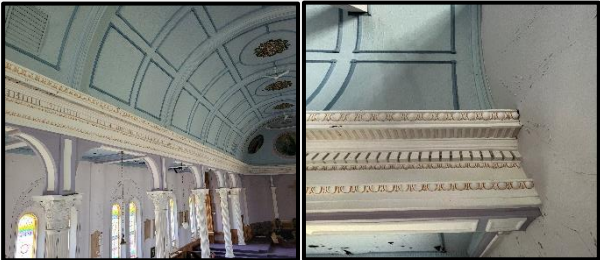
<p>Pressed Tin/Sheet Metal Panels</p>	<p>Cornice</p>	<p>Fair to Good</p>	<p>The decorative cornice with dentils and egg-and-dart patterning located throughout the nave and upper gallery was observed to be in fair to good condition. Constructed of pressed tin/sheet metal, the cornice showed some deteriorated and flaking paint finishes, but no major corrosion or missing components of the pressed tin/metal were noted.</p> <p>While the pressed tin/sheet metal panels comprising the cornice are included as a heritage attribute in the property's designation By-law, they are not considered to be distinctive element in isolation. If appropriate, a portion of the cornice material could be removed and conserved as part of a commemoration plan.</p>

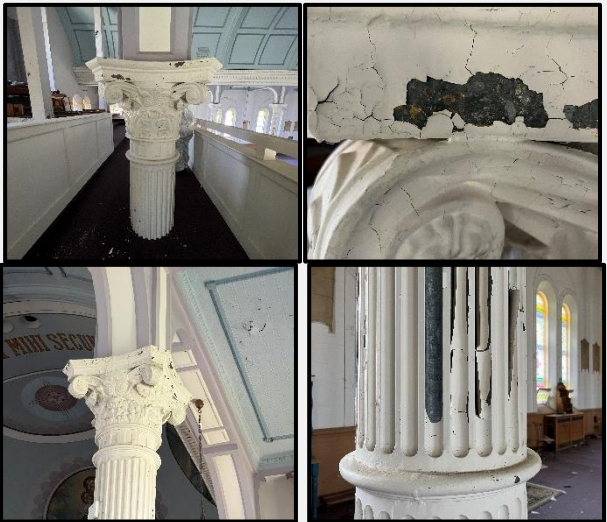
<p>Pressed Tin/Sheet Metal</p>	<p>Columns</p>	<p>Fair to Good</p>	<p>The Corinthian columns located throughout the nave and upper gallery were observed to be in fair to good condition.</p> <p>Constructed of pressed tin/sheet metal, the decorative columns showed some deteriorated and flaking paint finishes, but no major corrosion or missing components of the pressed tin/metal were noted.</p> <p>As a defining element of the church's interior ornamentation, the salvage of some or all of the columns should be considered high priority for inclusion as part of a future commemoration plan.</p> <p>If only a selection of the columns is to be stored for future use in a commemoration plan the remaining columns should be salvaged, allowing the material to be reused/recycled elsewhere.</p>

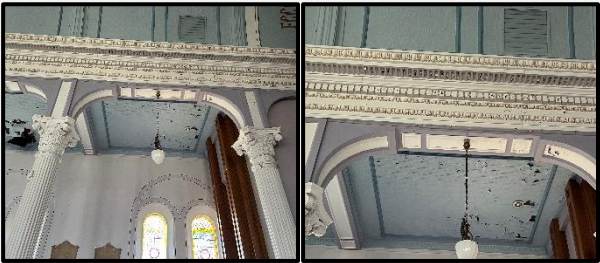
<p>Pressed Tin/Sheet Metal</p>	<p>Arcade</p>	<p>Fair to Good</p>	<p>The curved pressed tin/sheet metal arcade spanning between the nave's Corinthian columns were observed to be in fair to good condition. Constructed of pressed tin/sheet metal, the decorative curved arcade showed some deterioration and flaking paint finishes, but no major corrosion or missing components were noted.</p> <p>While the curved pressed tin/sheet metal parts of the arcade conjoin with the Corinthian columns and are included as a heritage attribute in the property's designation By-law, they are not considered to be distinctive elements in isolation. If appropriate, the arcade materials could be removed and conserved as part of a commemoration plan.</p> <p>If the arcade is not selected to be a part of a future commemoration plan, the arcade materials should be salvaged for reuse/recycling elsewhere.</p>

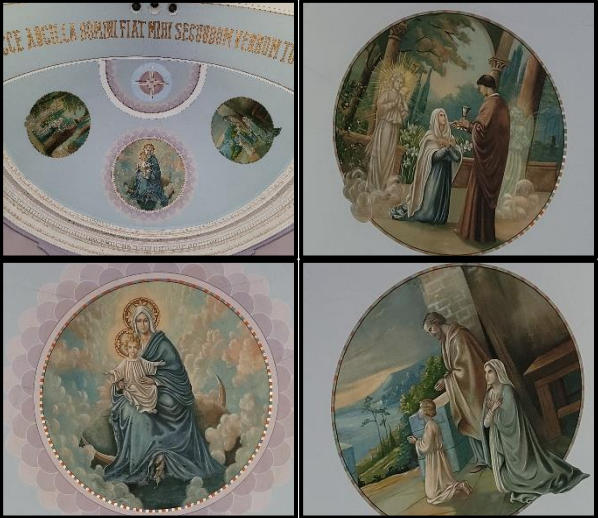
<p>Paint on Pressed Tin/Sheet Metal Panels</p>	<p>Bible verse, cross and roundels painted on the ceiling above the altar</p>	<p>Excellent</p>	<p>The painted bible verse, cross and roundels are painted onto plain pressed tin/sheet metal panels and were observed to be in excellent condition overall. The paint finishes were intact with no deteriorated areas noted.</p> <p>Given that the paintings are completed on pressed tin/sheet metal panels, there is the potential to salvage and reassemble these paintings in a new location.</p> <p>As a defining aspect of the former church's interior that reinforces the building's previous use and is a listed heritage attribute in the property's designation By-law, these panels should be considered a high priority for salvaging and reuse as part of a commemoration plan for the property.</p>

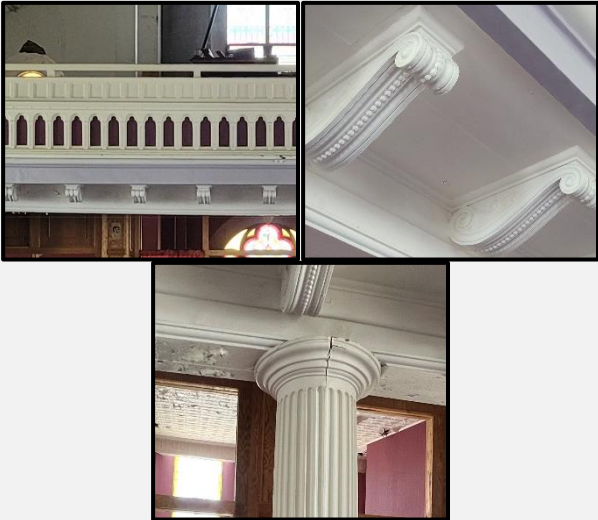
<p>Pressed Tin/Sheet Metal</p>	<p>Columns and balustrade at the gallery</p>	<p>Fair to Excellent</p>	<p>The columns supporting the gallery were observed to be in fair condition. Constructed of pressed tin/sheet metal, vertical cracking was observed, potentially associated with a displaced load of the gallery above.</p> <p>The decorative balustrade is also constructed of pressed tin/sheet metal and features decorative bracketing/scrollwork. Both the balustrade and bracketing were observed to be in excellent condition, with intact painted finishes and no noted signs of deterioration.</p> <p>If appropriate, the columns and balustrade including the decorative bracketing materials have the potential to be salvaged and conserved as part of a commemoration plan.</p>

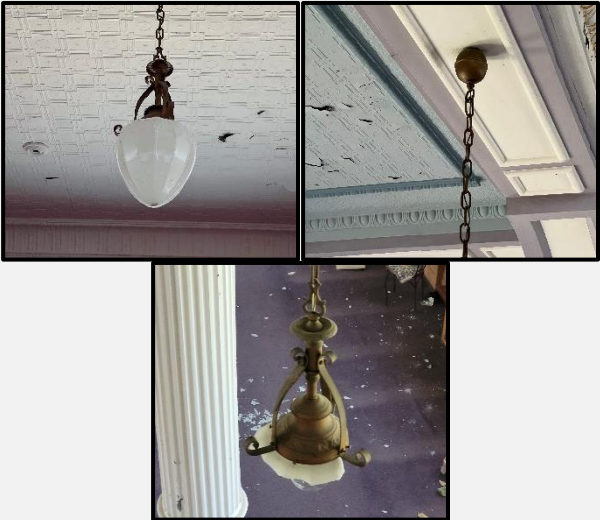
<p>Glass and Metal of Unknown Type</p>	<p>Light Fixtures</p>	<p>Poor to Good</p>	<p>The pendant light fixtures throughout the interior of the church are recognized as a heritage attribute in the property's designation By-law and were observed to be in varying condition.</p> <p>While a handful of the light fixtures were intact, the majority of the opaque glass on the light fixtures was broken.</p> <p>The functionality of the intact light fixtures was not tested.</p> <p>While these light fixtures are included in the property's designation By-law, they represent a common design motif seen in church's constructed in the early 20th century throughout Ontario. As such, while these light fixtures could be salvaged for a future commemoration plan, it is not considered a high priority for inclusion.</p> <p>Any remaining intact light fixtures should be considered for salvage and recycling/reuse elsewhere.</p>

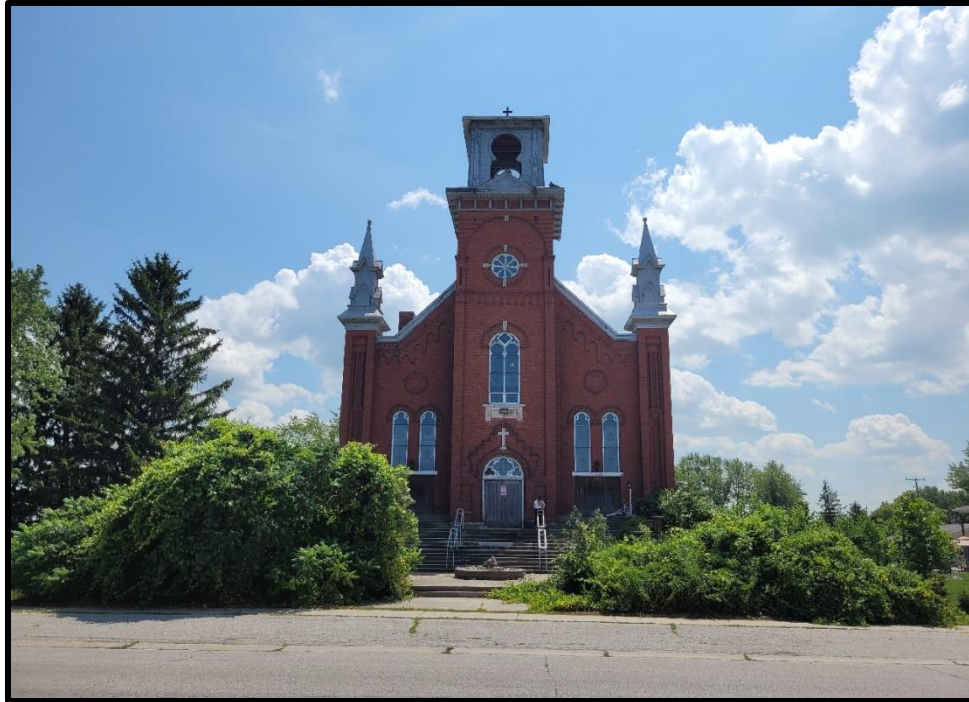
Image 9: 7119 Tecumseh Road Exterior – Façade
(Photo taken June 22, 2022; Facing South)

The church has a symmetrical, three-bay façade that faces north towards Tecumseh Road (see Image 9). Concrete stairs provide access to the three entrance doors which span the entire façade. The brick masonry along the façade features projecting brick masonry units, banding, and corbelling, creating a strong decorative effect (see Image 12). A round window opening is located directly below the belfry, otherwise all openings area framed by a rounded arch with projecting brick voussoirs. Limestone keystones or sills further embellish the window openings on the

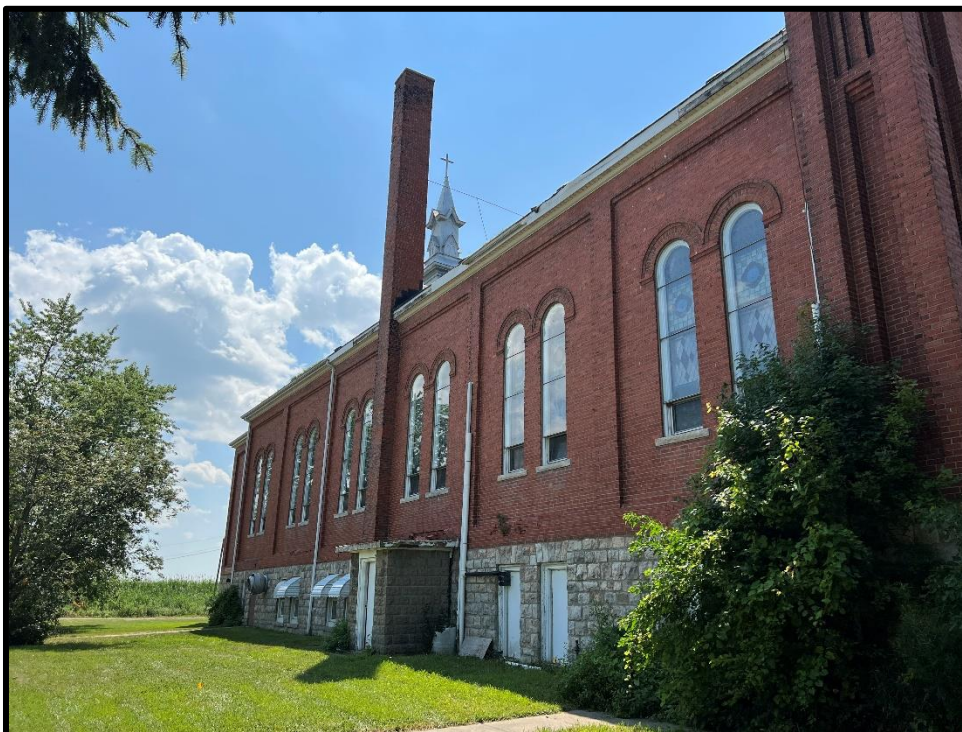
Image 14: 7119 Tecumseh Road Exterior – East Elevation
(Photo taken July 22, 2022; Facing Southwest)

The east elevation features similar decorative brickwork as seen on the façade with corbelled courses and projecting round arch voussoirs over the first storey window openings. The first storey window openings are paired, and all contain leaded stained glass windows of a similar design and have limestone sills (see Image 13). The building's coursed limestone foundation is further revealed on this elevation, showing the basement window openings to have either segmental or jack arches with angled stone voussoirs. A tall brick chimney extends above the roofline on this elevation (see Image 14). An entrance portico constructed of rock-faced concrete block with a flat roof is located on the east elevation and provides access to the basement storey. A secondary entrance to the basement storey is located on this elevation towards the rear of the building (see Image 15). A spirelet constructed of pressed tin and of a similar design to the pinnacles on the façade is located along the ridgeline and visible from the east, south and west elevations.

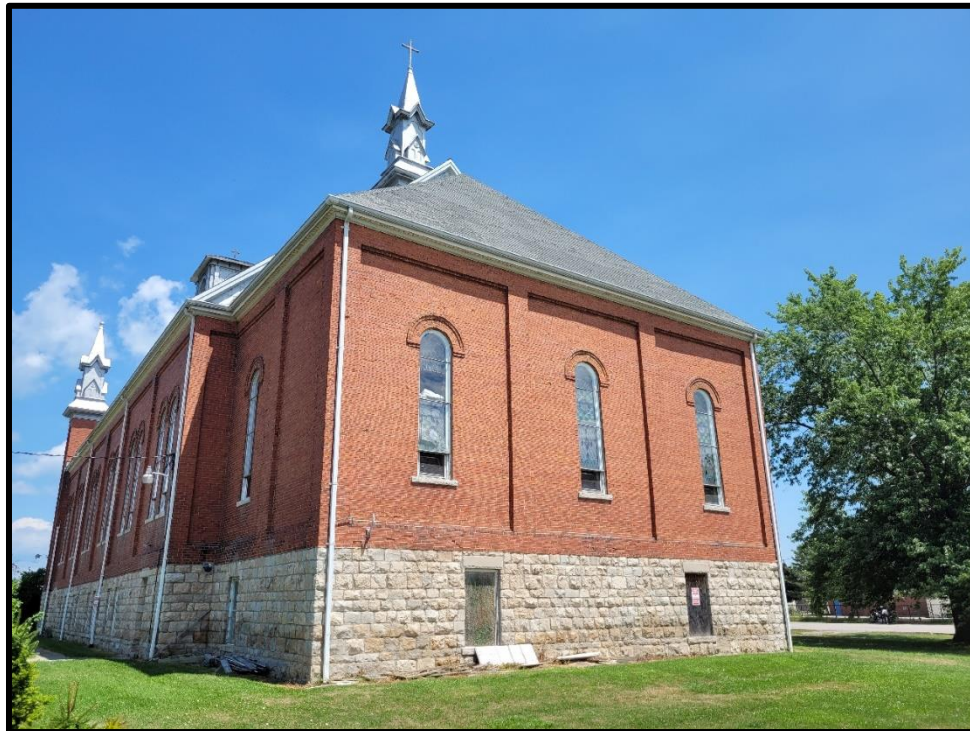
Image 16: 7119 Tecumseh Road Exterior – South (Rear) Elevation
(Photo taken July 22, 2022; Facing Northeast)

The south elevation contains three single windows opening of the same design as the windows described on the east elevation (see Image 16). The brickwork detailing also matches the decorative elements described along the façade. Two basement windows are located on the south elevation, both of which have been boarded up. The rear of the building, the former chancel of the church is slightly narrower than the nave and has a hip roof that has been clad in asphalt shingles.

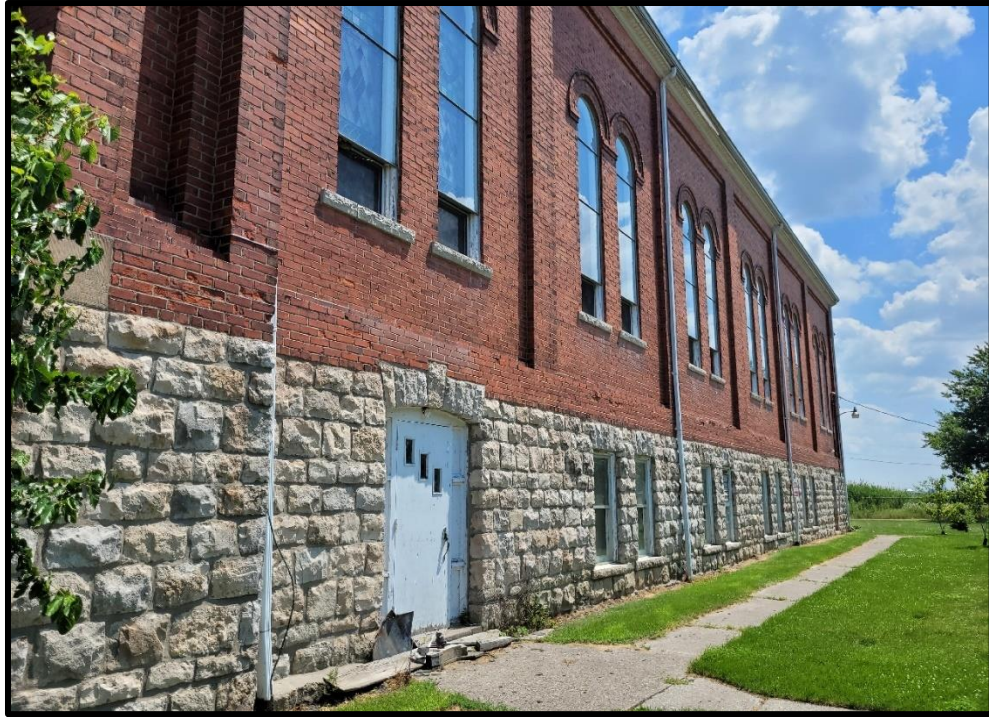
Image 17: 7119 Tecumseh Road Exterior – West Elevation
(Photo taken July 22, 2022; Facing South)

The west elevation features the same decorative elements and fenestration as described on the east elevation, though no portico or chimney is present on this elevation (see Image 17). A datestone is located at the northwest corner of the building, located above the limestone foundation course and reads "A.D. 1905" (see Image 18).

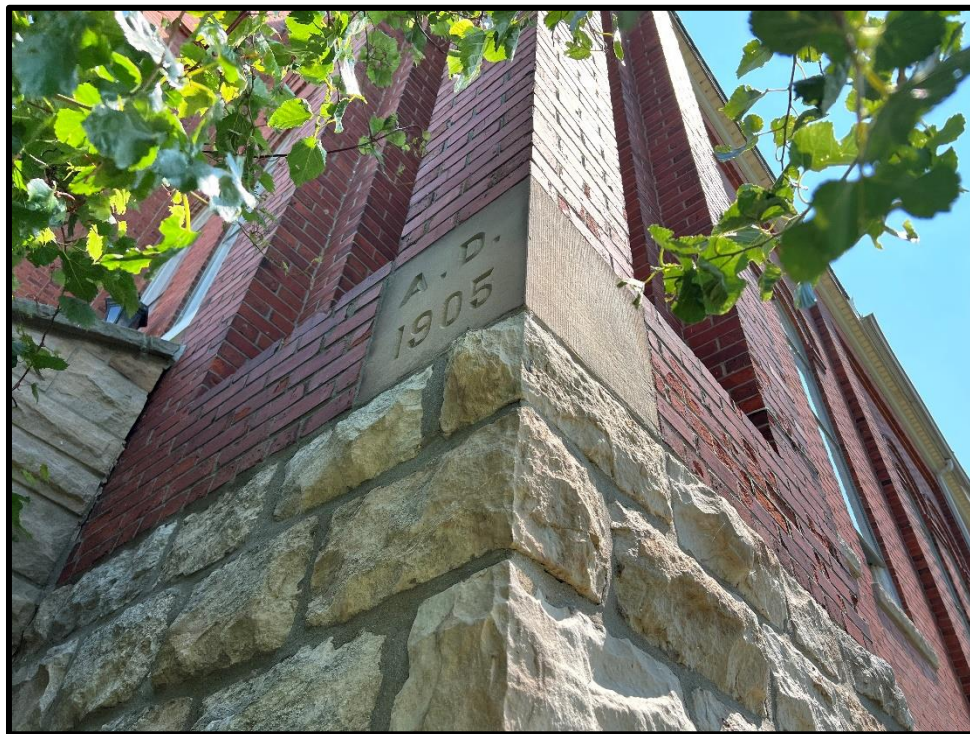
Image 18: 7119 Tecumseh Road Exterior – Datestone
(Photo taken July 22, 2022; Facing Southeast)

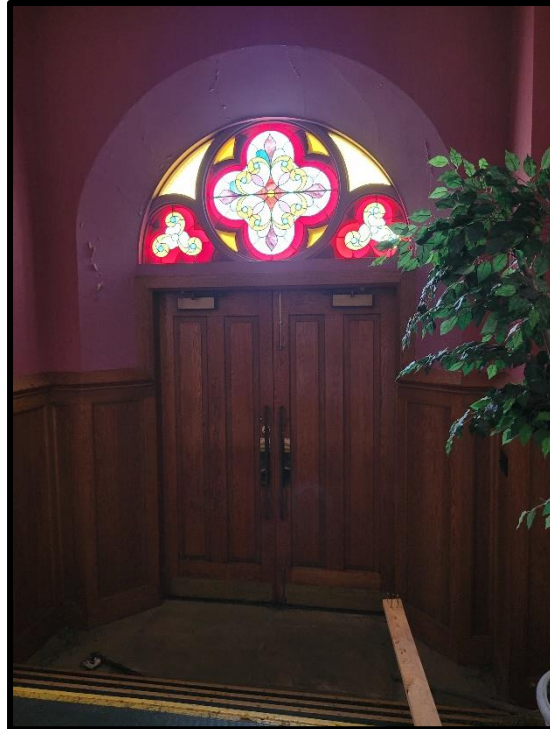
Image 19: 7119 Tecumseh Road Interior – Façade Entrance
(Photo taken July 22, 2022)

The façade's centre entrance opens to a raised entrance lobby or narthex, the walls of which are finished with wooden oak paneling (see Image 19 and Image 21). The narthex opens to the nave and aisles, a largely open space with a vaulted roof that is supported by Corinthian columns constructed of pressed tin (see Image 22–Image 24). A raised apse is located along the southern end of the first floor where four wooden pilasters are evenly spaced along the curved wall (see Image 25).

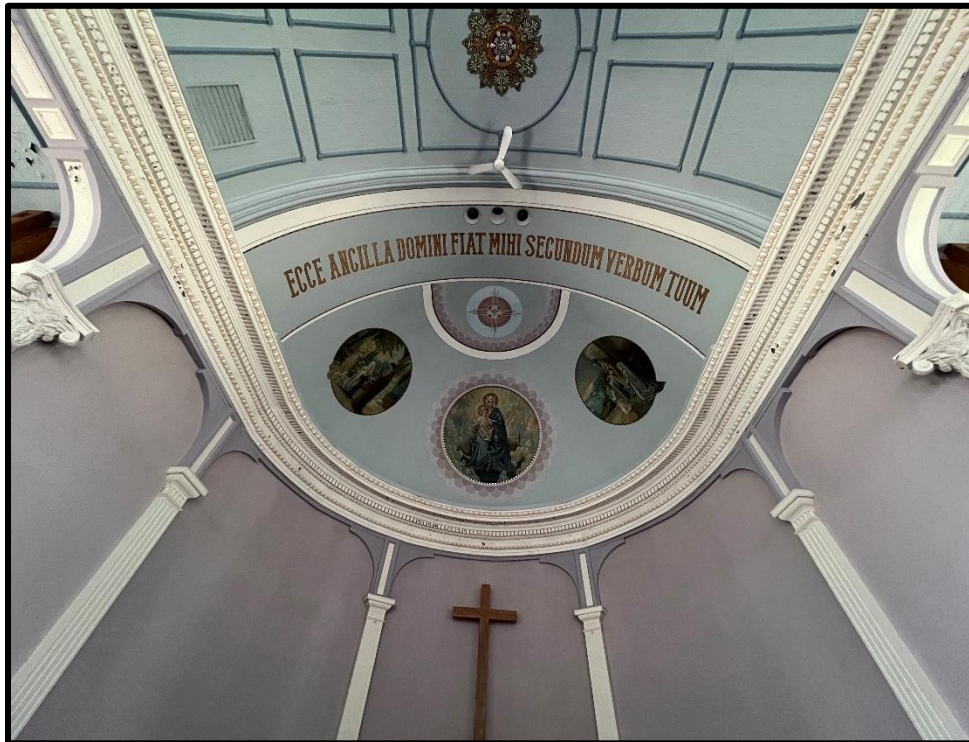
Image 26: 7119 Tecumseh Road Interior – Painted Tin Ceiling
(Photo taken July 22, 2022)

The vaulted roof is also constructed of pressed tin, which has been painted. A large mural with three biblical motifs and the words "Ecce Ancilla Domini Fiat Mihi Secundum Verbum Tuum" are painted on the ceiling and located directly above the apse (see Image 26 and Image 27). The pressed tin ceiling features decorative ceiling medallions and a pressed tin cornice with dentils and an egg-and-dart pattern wraps around the perimeter of the first storey (see Image 28 and

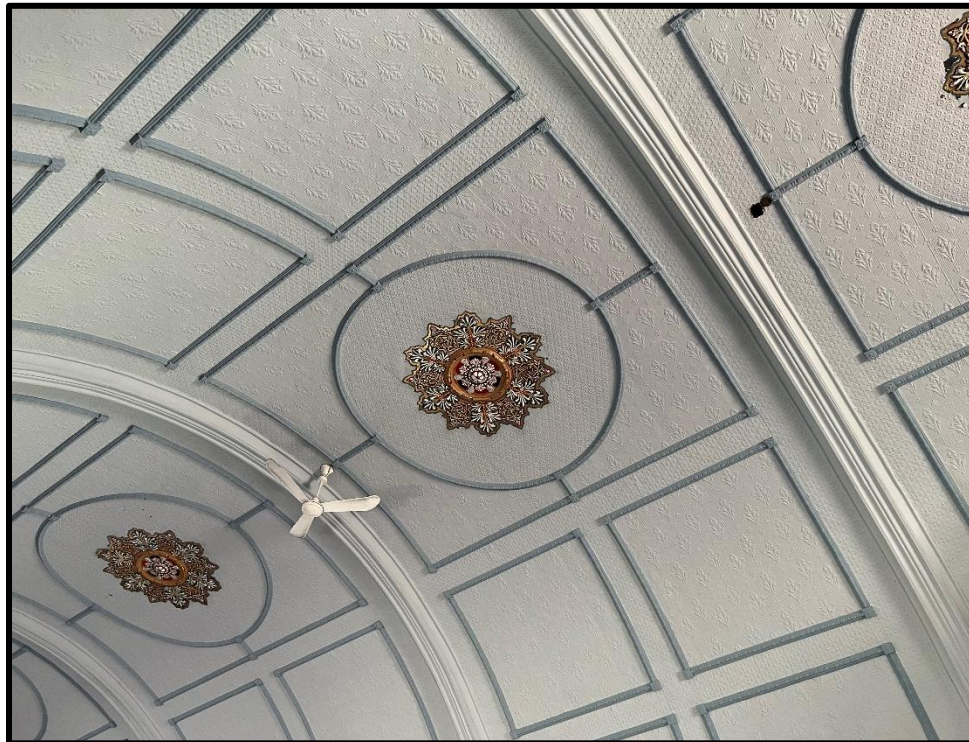
Image 28: 7119 Tecumseh Road Interior Detail – Pressed Tin Ceiling
(Photo taken July 22, 2022)

Image 29). The ambulatory wraps around the rear of the apse and is clad in wood paneling and has a small kitchenette space and stairs leading to the basement level of the church (see Image 30–Image 32).

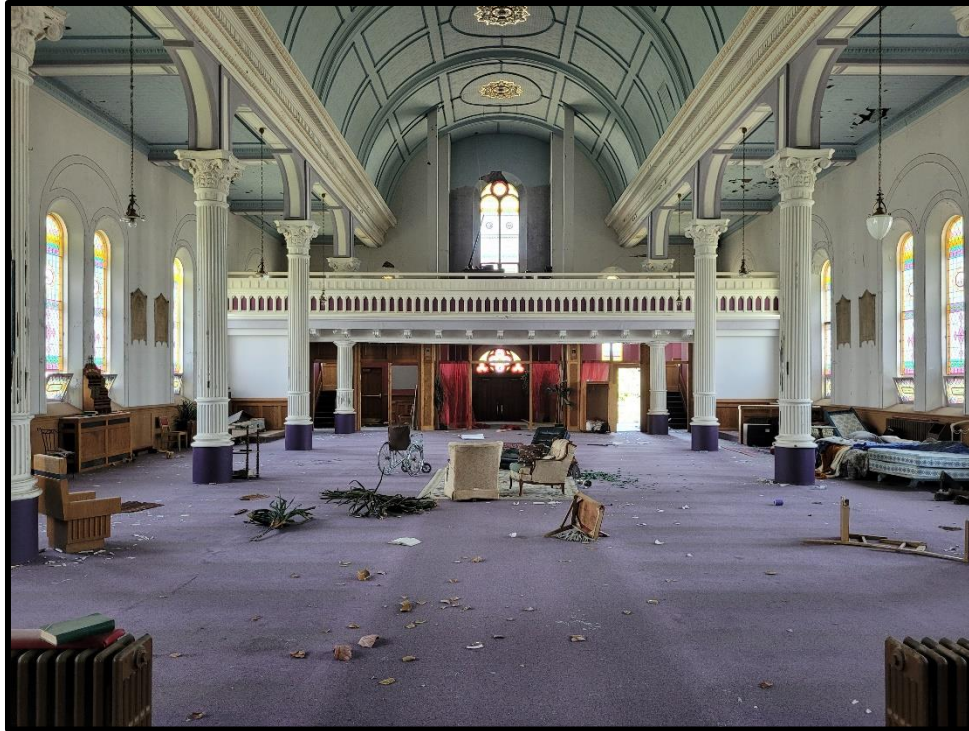
Image 33: 7119 Tecumseh Road Interior – Rear Balcony Above Narthex
(Photo taken July 22, 2022)

A balcony is located at the northern end of the nave and also features pressed tin ornamentation in the form of bracketing and along the balcony ridge (see Image 33 to Image 35). Stairs to the balcony are located on both the east and west sides of the balcony (see Image 36 and Image 37). Two of the pressed tin Corinthian columns located in the balcony are accessible and cracking paint reveals the columns were previously painted gold (see Image 38 and Image 39). A ceiling hatch that would provide access to the belltower and belfry is located at the approximate centre of the balcony along the northern wall (see Image 40 and Image 41). A significant leak, located at the northeastern corner of the balcony has resulted in portions of the tin ceiling falling (see Image 42).

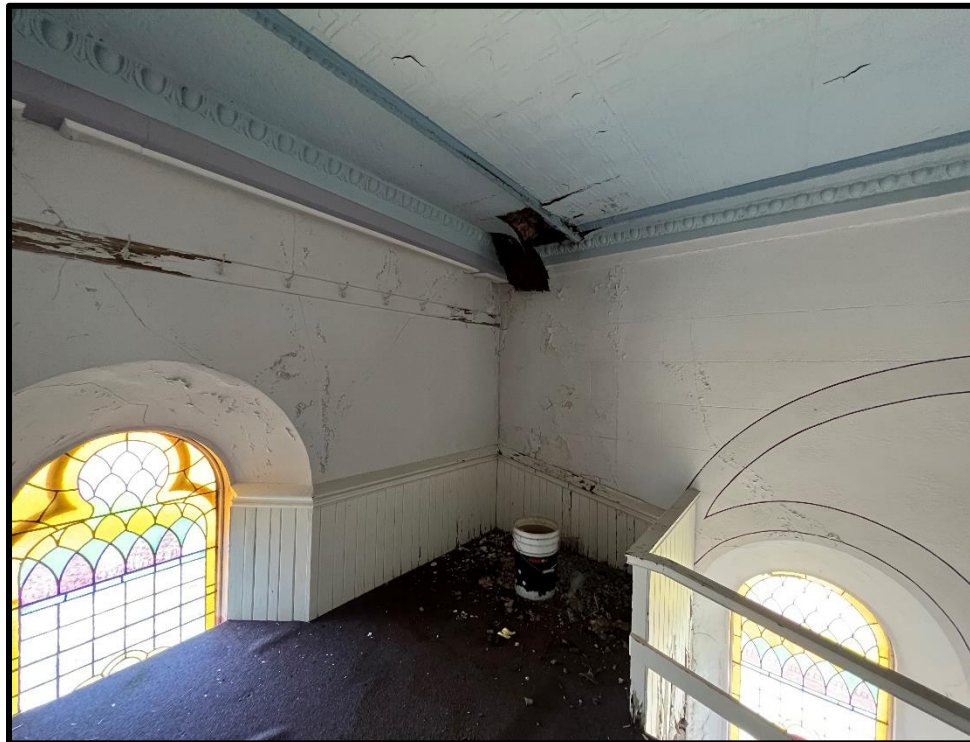
Image 42: 7119 Tecumseh Road Interior – Leakage Through Tin Roof in Balcony
(Photo taken July 22, 2022)

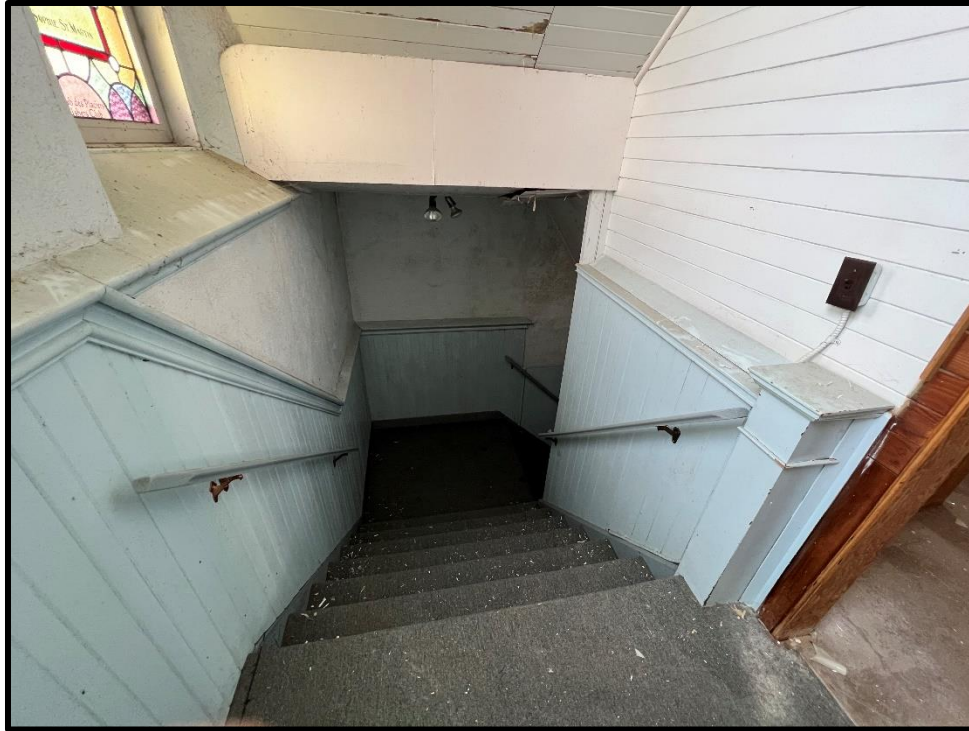
Image 43: 7119 Tecumseh Road Interior – Stairs to Basement
(Photo taken July 22, 2022)

The basement of the church is accessed via staircases on the east and west side of the narthex with beadboard paneling along the walls (see Image 43 and Image 44). The bottom of the stairway is enclosed with paired wooden six-panel doors (see Image 45). The entire basement level was observed to be flooded, with approximately one inch of standing water, which has resulted in significant damage and deterioration to the interior of this floor. The basement features a terrazzo floor and has had a dropped tile ceiling installed throughout. The basement staircases open to a hall area (see Image 46 and Image 46). The hall leads to a larger main room to the north. This room on this floor is a largely open space, supported by plain, iron columns (see Image 47 and Image 48). While the dropped tile ceiling remains largely in place, missing tiles reveal that the ceiling tiles have been installed over a tongue and groove wooden board ceiling finish (see Image 49). The basement also contains smaller rooms composed of bathrooms, a mechanical room and kitchenette (see Image 50 to Image 53). Extensive mold was present throughout this floor (see Image 51 and Image 52).

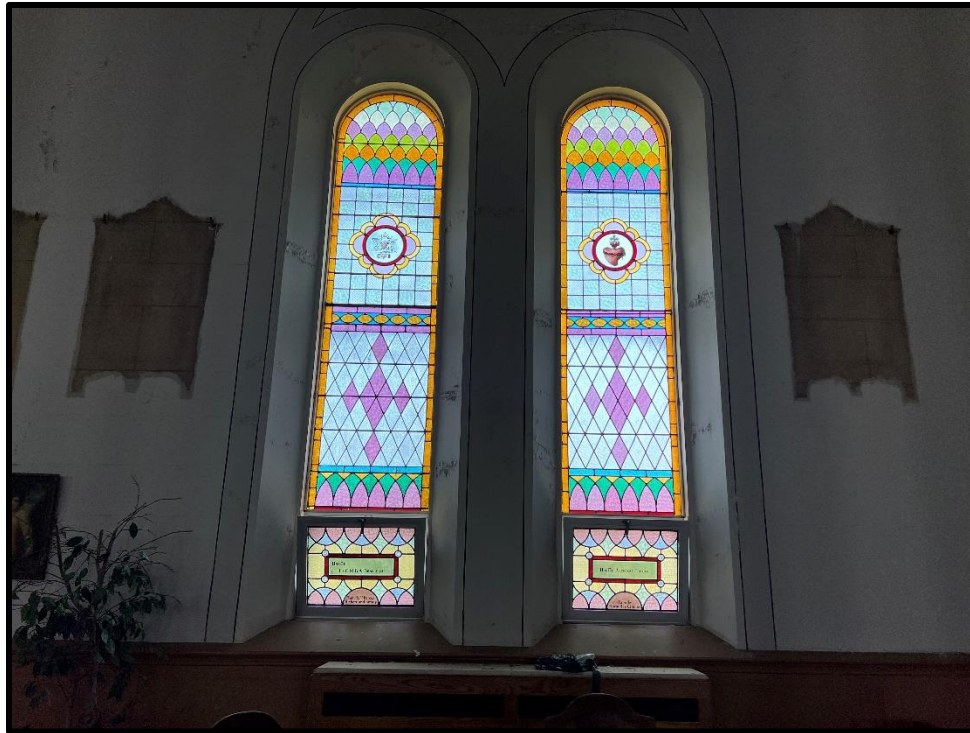
Image 54: 7119 Tecumseh Road Interior – Representative Photo of Basement Stained Glass Design
(Photo taken July 22, 2022)

The majority of the window openings in the church house leaded, stained glass windows which follow a similar design motif and colour scheme (see Image 54 and Image 55). The windows were observed to be in varying condition with many damaged and in some instances missing entirely (see Image 56 to Image 58).

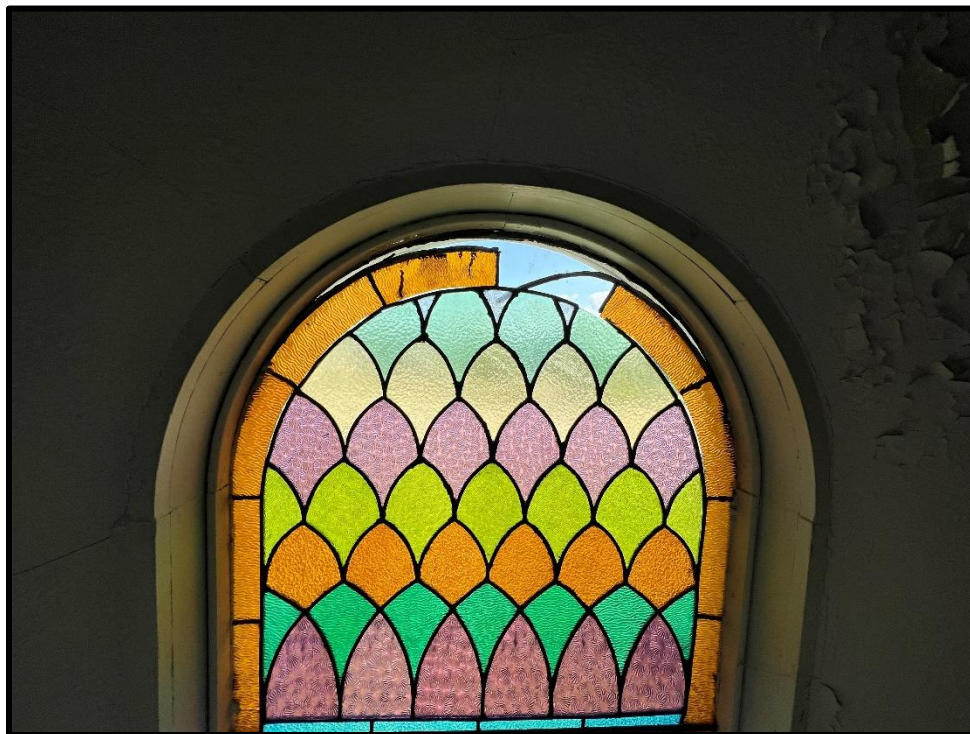
Image 56: 7119 Tecumseh Road Interior – Broken and Missing Components on Stained Glass Windows
(Photo taken July 22, 2022)

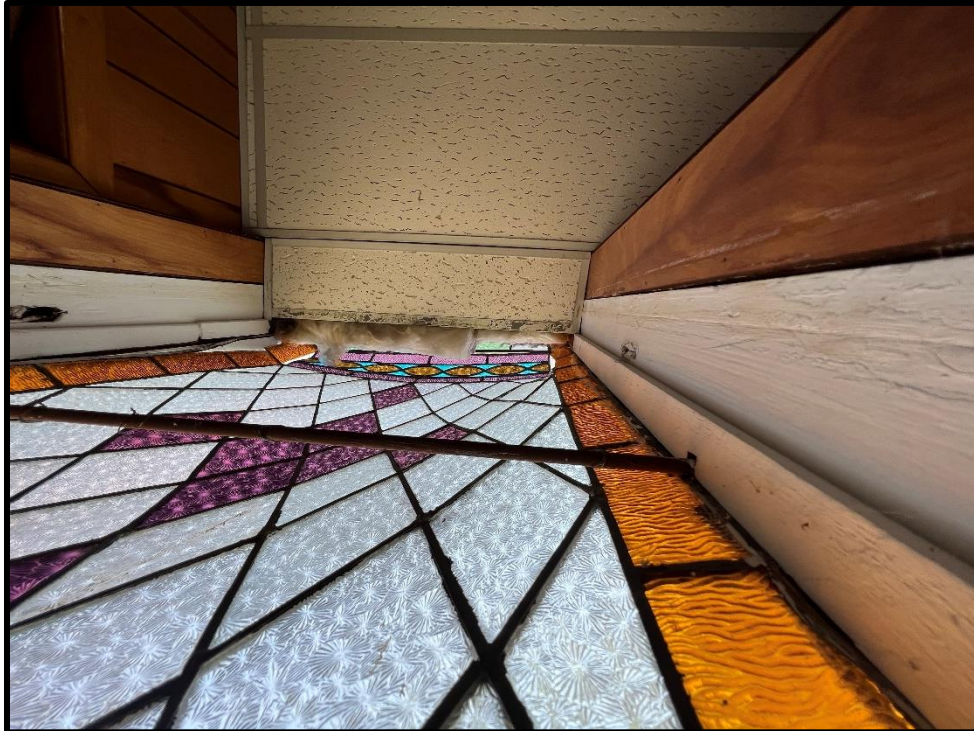
Image 57: 7119 Tecumseh Road Interior – Bowed and Warping Stained Glass Windows
(Photo taken July 22, 2022)

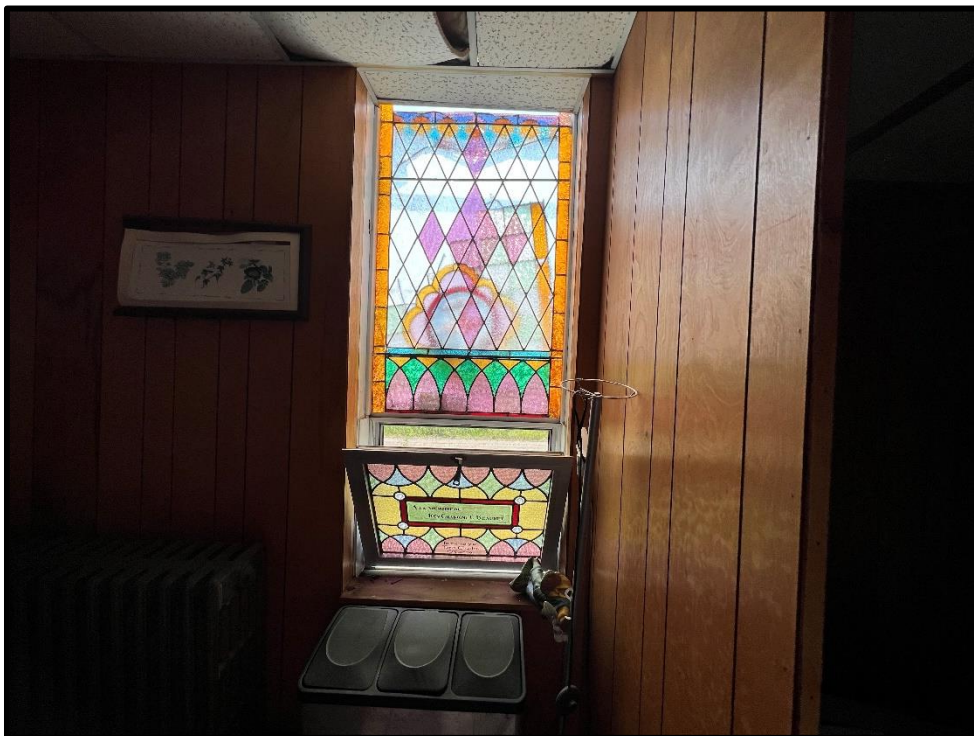
Image 58: 7119 Tecumseh Road Interior – Broken and Collapsed Stained Glass Window
(Photo taken July 22, 2022)
